Re: Report of the vertical facades of

Please see below a full facade survey of the above named property.

We have been instructed to perform an inspection of the vertical facades using a drone to identify defects.

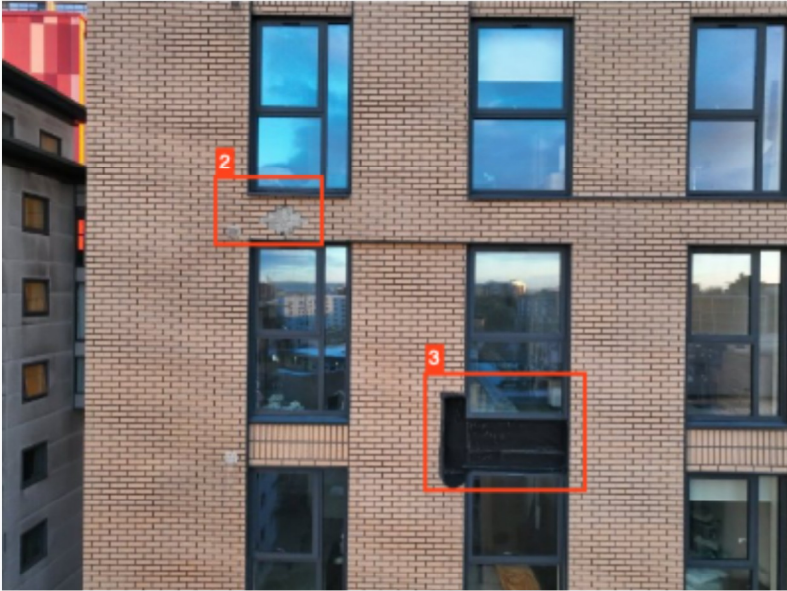
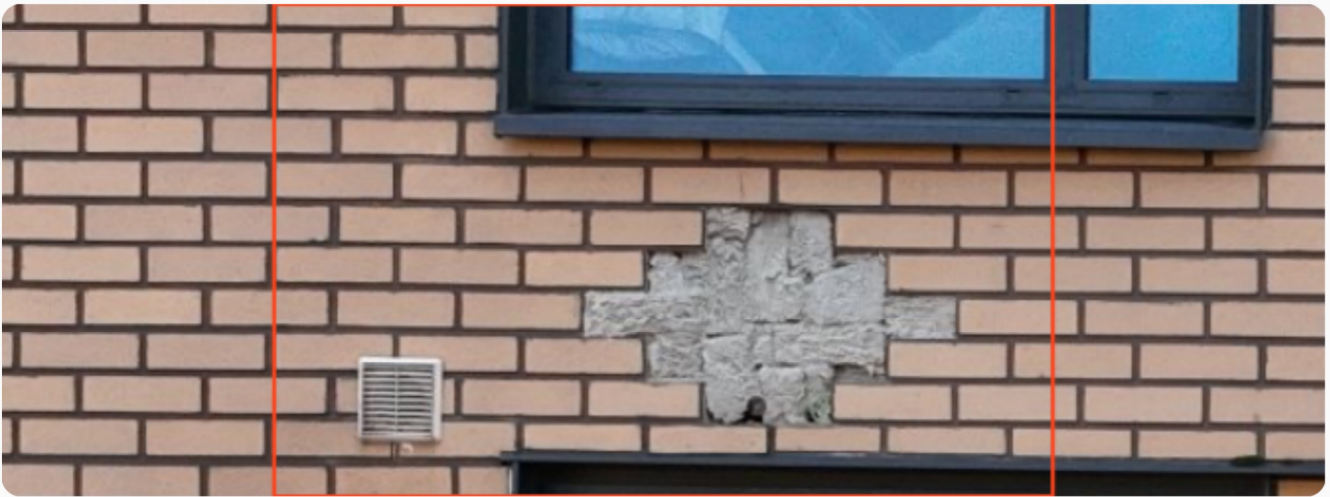
2

Severity 4

Damage

Cladding

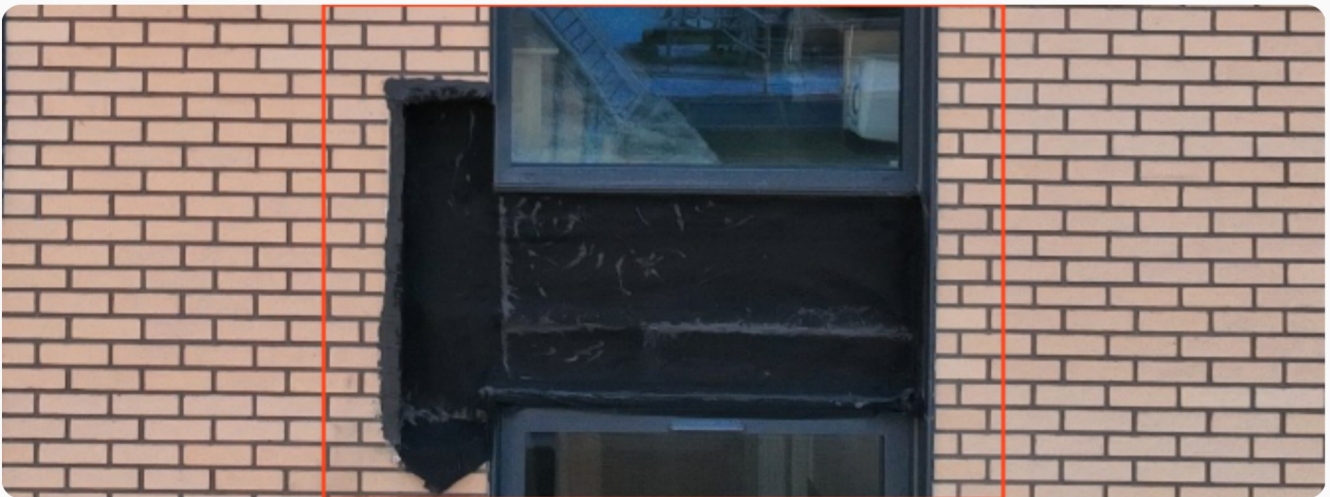
3

Severity 4

Damage

Cladding

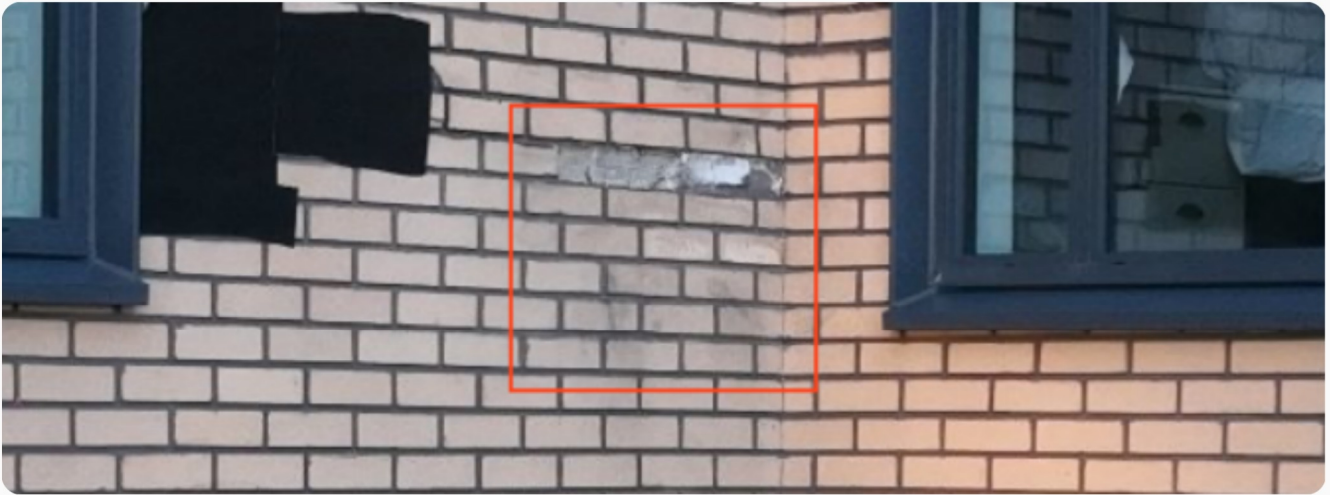
9

Severity 4

Damage

Cladding

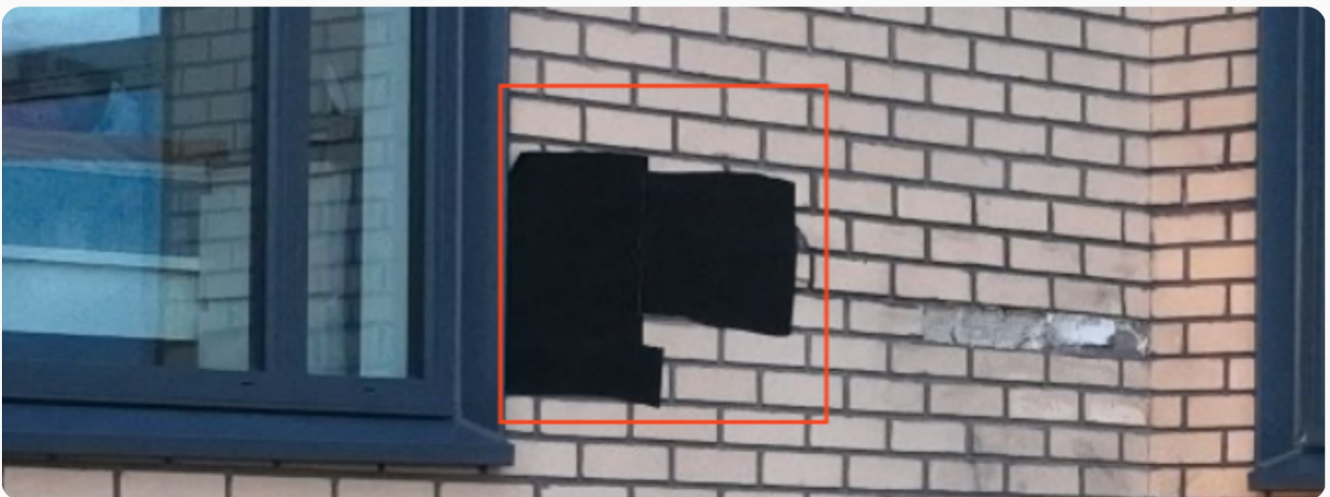
10

Severity 4

Damage

Cladding

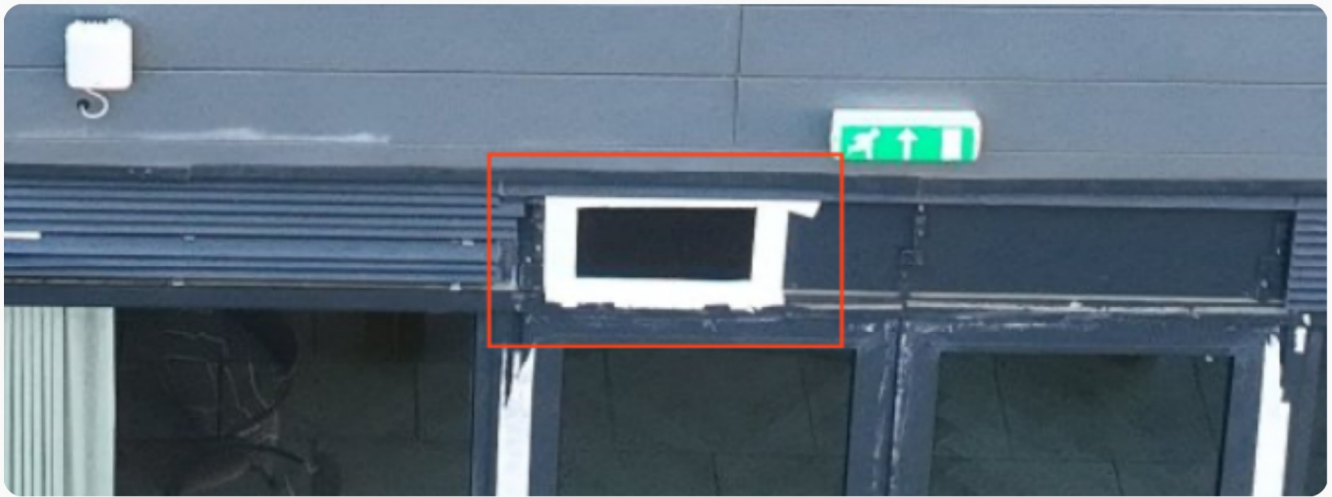
14

Severity 4

Damage

Cladding

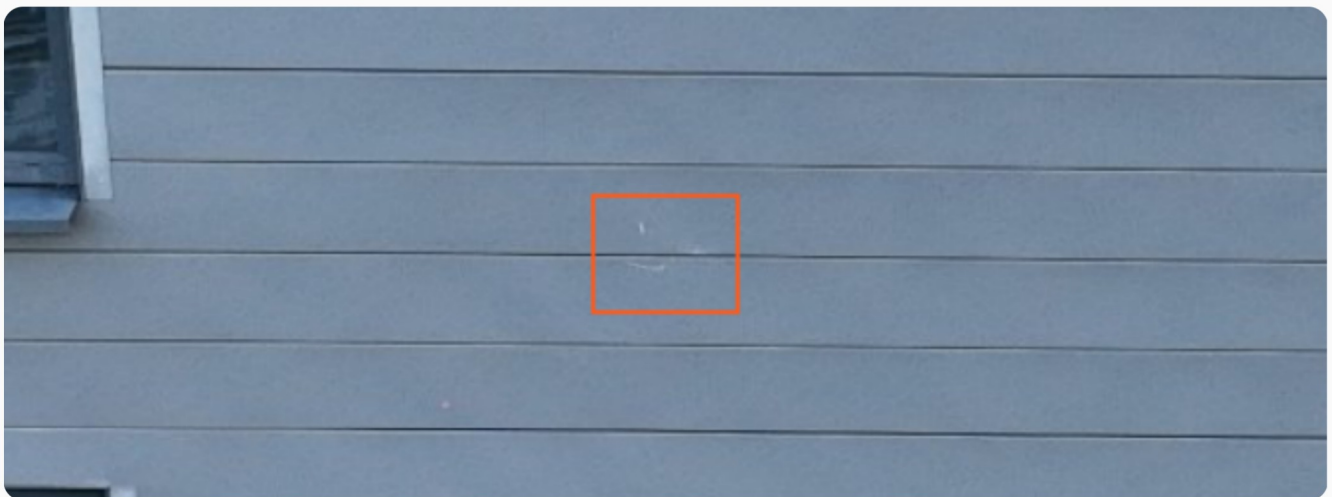
15

Severity 3

Damage

Cladding
