Full View

Aerial Imaging Solutions

Overview

We have been instructed to examine the general structure of the roof system and rainwater goods identifying any defects.

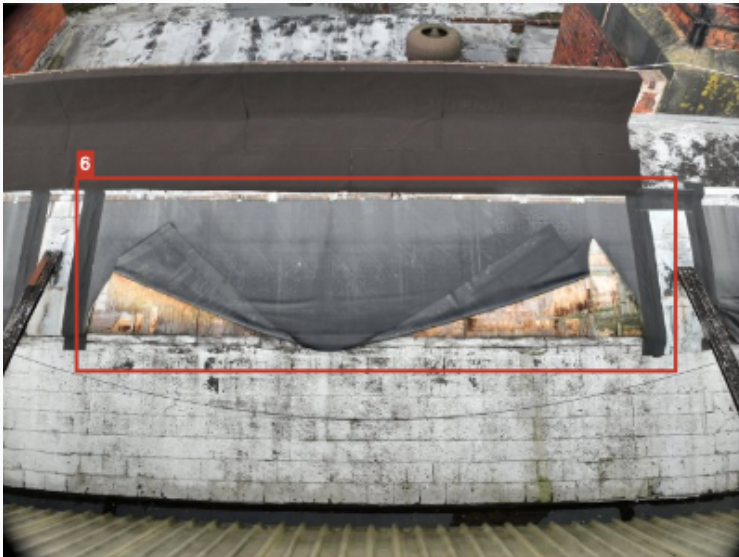
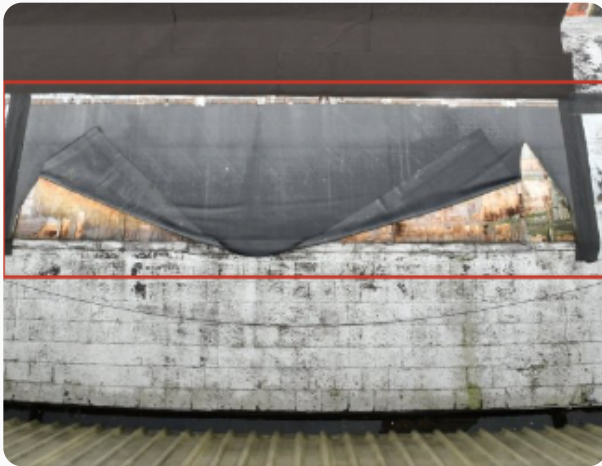
6

Severity 5

Damage

Roof

Damage to roof coverings. Water ingress certain at this point

Overall, the structural integrity of the roof is in poor condition and does not perform its basic function of keeping the building watertight. The sawtooth and flat roofs have been subject to poor patch repairs over the years in an attempt to prolong the life of the roof. Left unchecked the roof will completely fail. Due to the sheer number of patch repairs and damaged areas on the roof system it is clear the roof coverings have far exceeded their serviceable life and should be replaced with new.

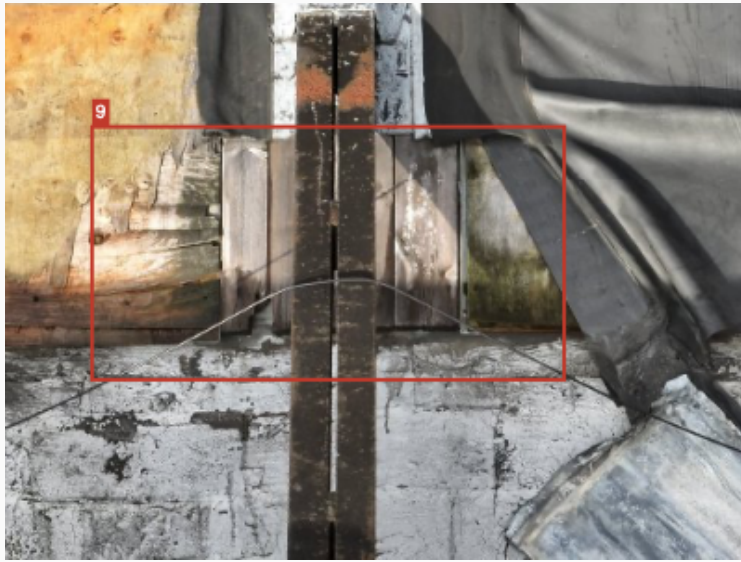
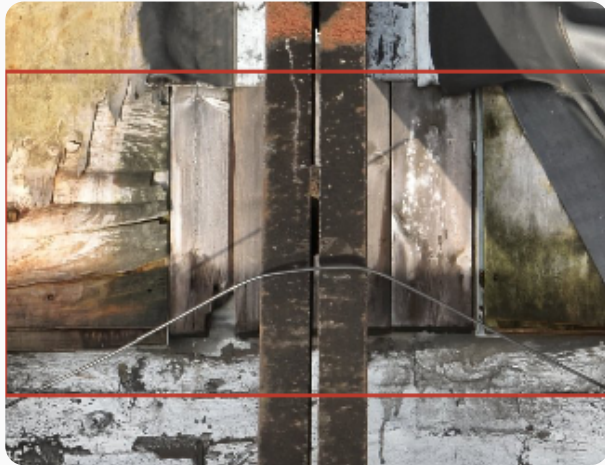
9

Severity 5

Damage

Roof

Damage to roof coverings. Water ingress certain at this point

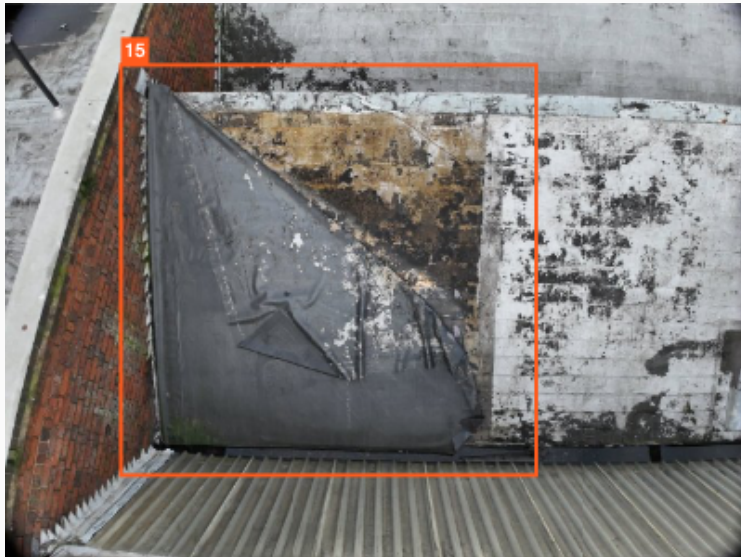
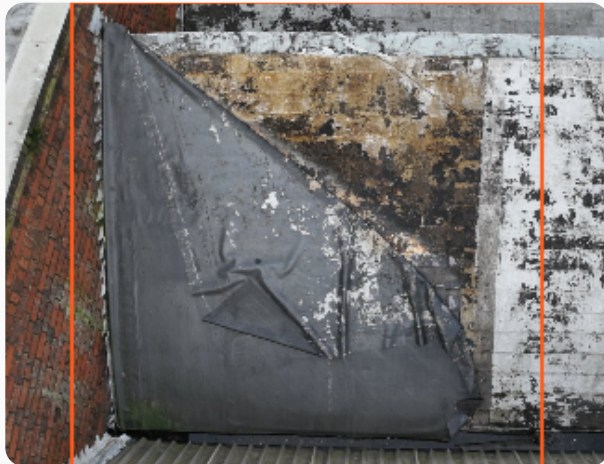
15

Severity 3

Existing repair

Roof

Existing repair to large areas of the roofing system

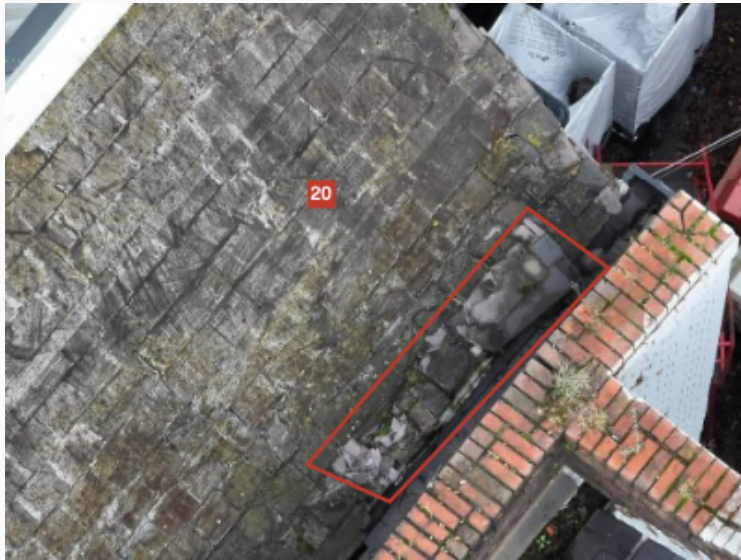
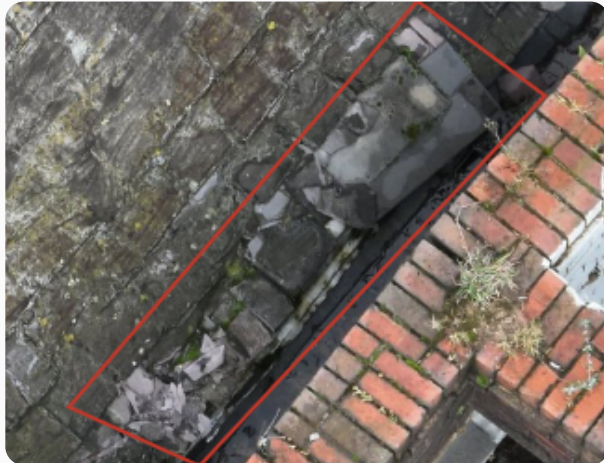
20

Severity 5

Missing

Roof

Cluster of missing, loose and broken roof tiles
