Thermal Survey Report – Solar PV Array

Location: [REDACTED]

Survey Date: 8th August 2025

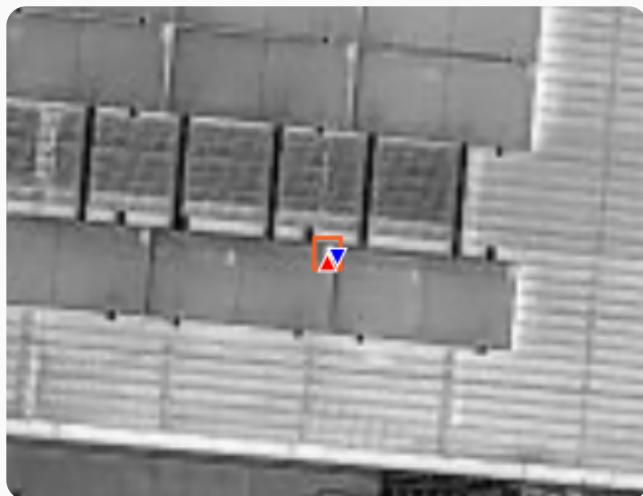
1

Severity 3

Hot Spot

Cell

**ⓘ Thermal Readings:**

~Avg : 30.136° Δ : 8.5°

▲ : 34.5° ▼ : 26°

1. **Comprehensive cleaning** of the entire solar PV array to remove dust, debris, and biological contaminants.
2. **Repeat thermal survey post-cleaning** to verify if the previously observed hot spots persist. Persistent anomalies would indicate potential **cell or module faults** requiring further diagnostic testing.
3. **Implement a routine cleaning and inspection schedule** to maintain optimal performance and prevent debris-related hot spots from developing.
4. Consider **bird deterrent measures** if guano contamination continues to be an ongoing issue.

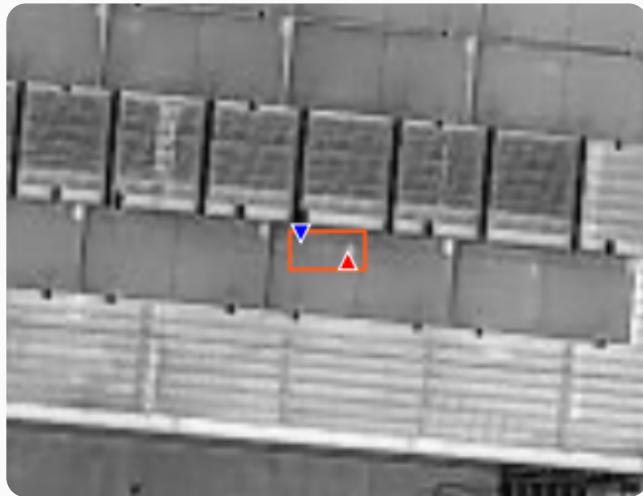
2

Severity 3

Hot Spot

Cell

**ⓘ Thermal Readings:**

~Avg : 27.603° Δ : 9.3°

▲ : 30.3° ▼ : 21°

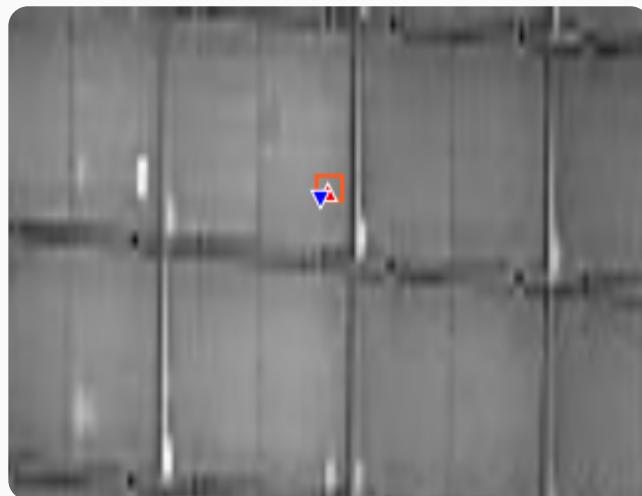
21

Severity 3

Hot Spot

Cell

**ⓘ Thermal Readings:**

~Avg : 31.977° Δ : 3.2°
▲ : 33.7° ▼ : 30.5°

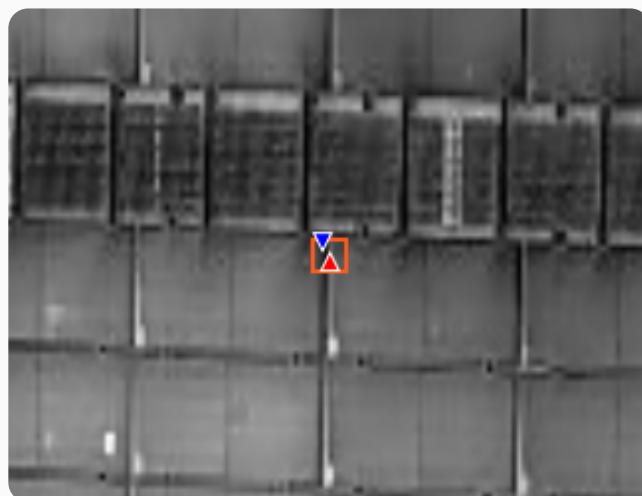
22

Severity 3

Hot Spot

Cell

**ⓘ Thermal Readings:**

~Avg : 30.845° Δ : 6.5°
▲ : 35° ▼ : 28.5°

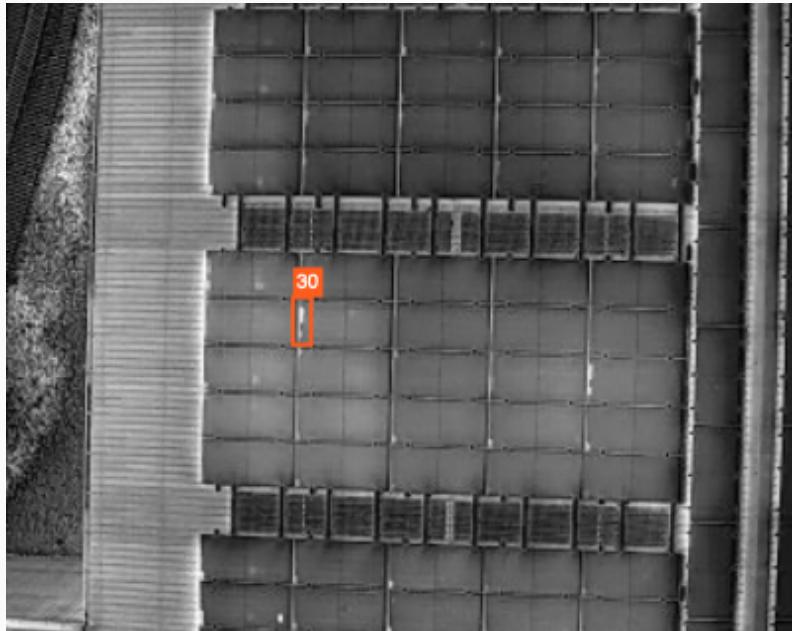
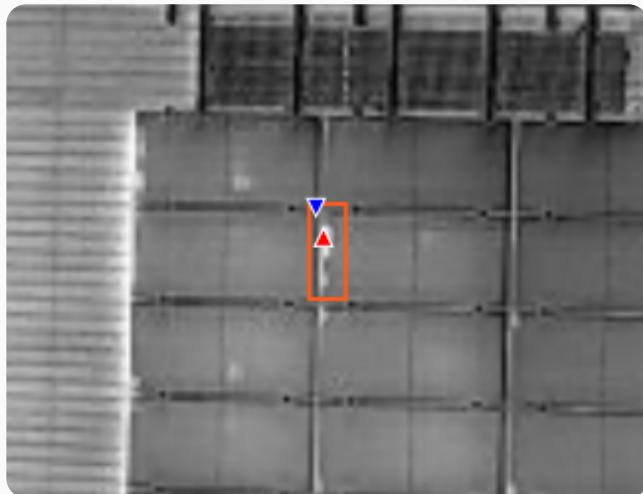
30

Severity 3

Hot Spot

Cell

**ⓘ Thermal Readings:**

~Avg : 31.656° Δ : 9°
▲ : 37.6° ▼ : 28.6°

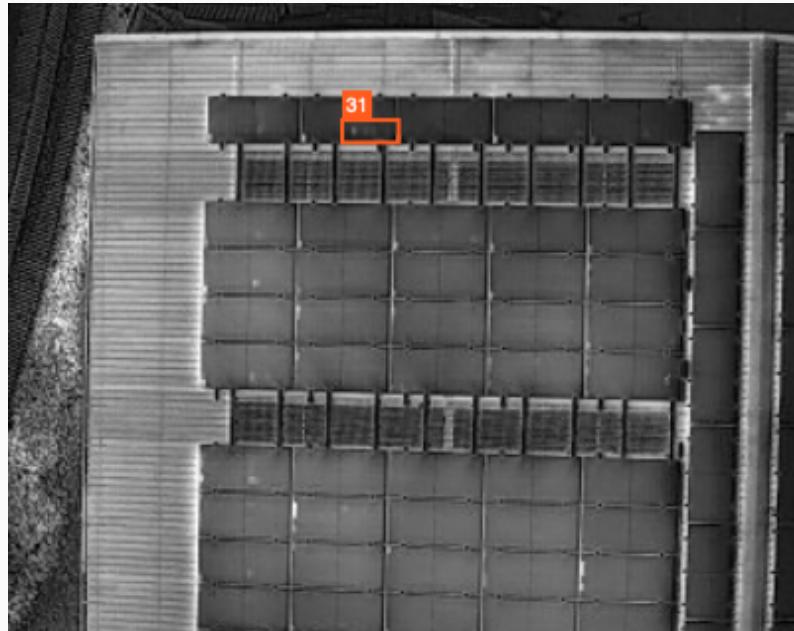
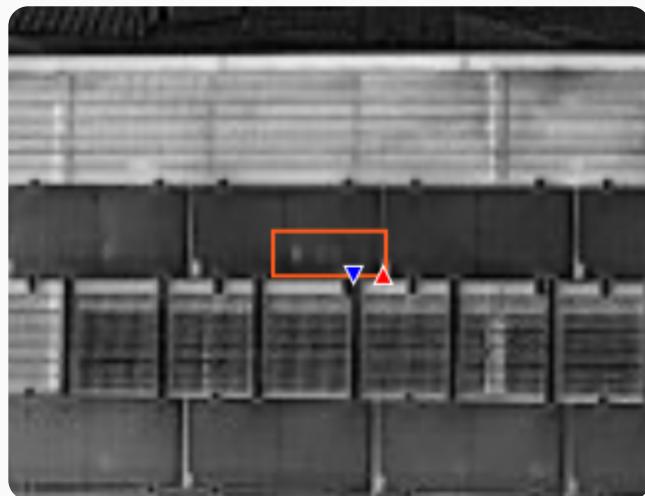
31

Severity 3

Hot Spot

Cell

**ⓘ Thermal Readings:**

~Avg : 25.822° Δ : 6.4°
▲ : 29.2° ▼ : 22.8°
