# Full View

Aerial Imaging Solutions

## Overview

The areas in question consist of flat roofs with differing roof systems.

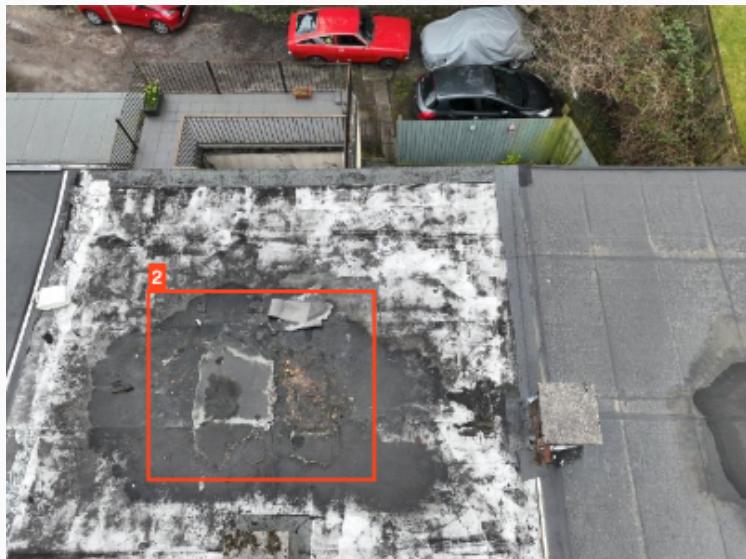
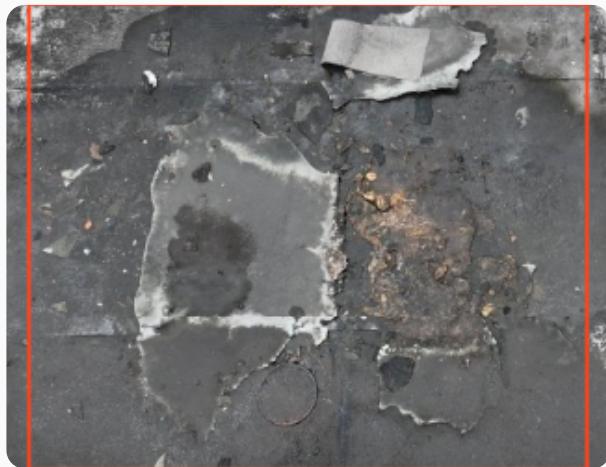
# 2

Severity 4

Damage

Deterioration to roof coverings

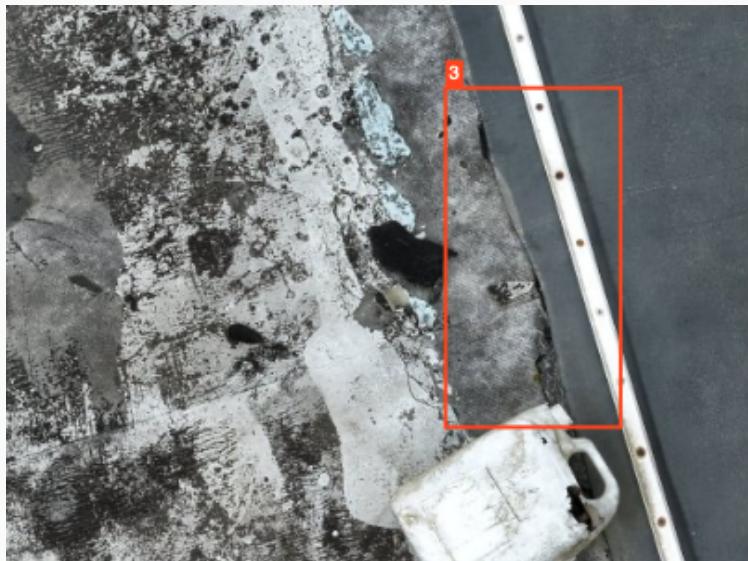
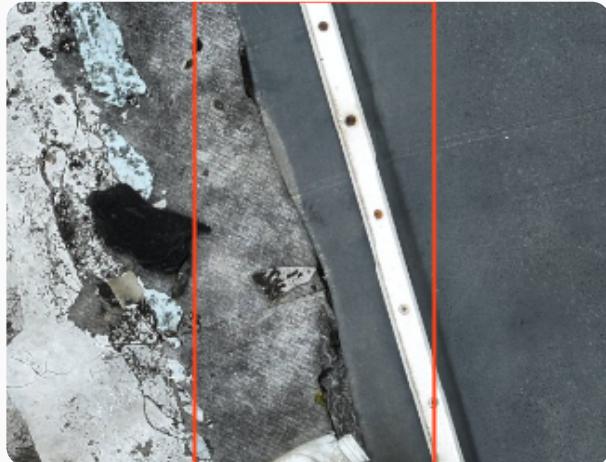
# 3

Severity 4

Other Issue

Failed junction between the two roof coverings

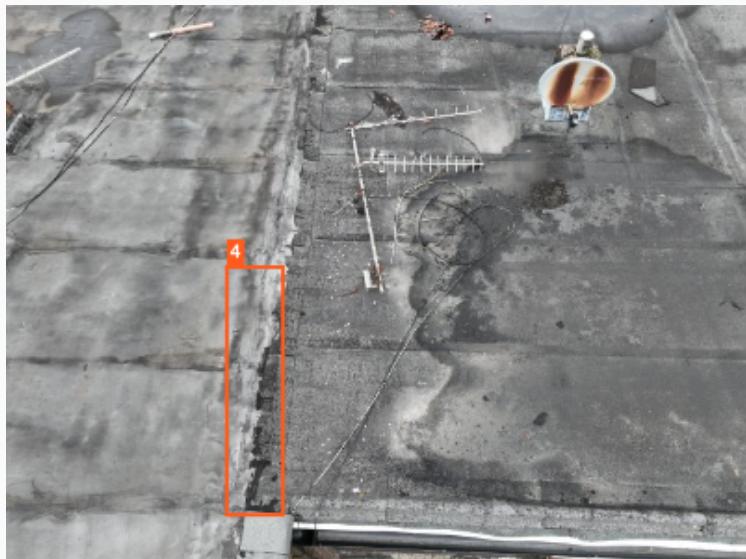
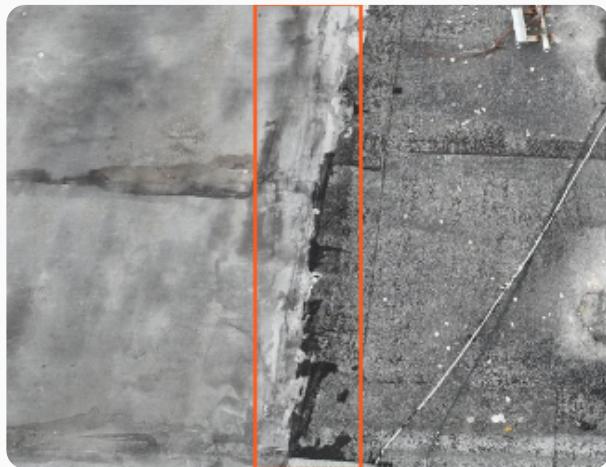
# 4

Severity 3

⚠ Existing repair

**Alex Herman**  
Existing repair

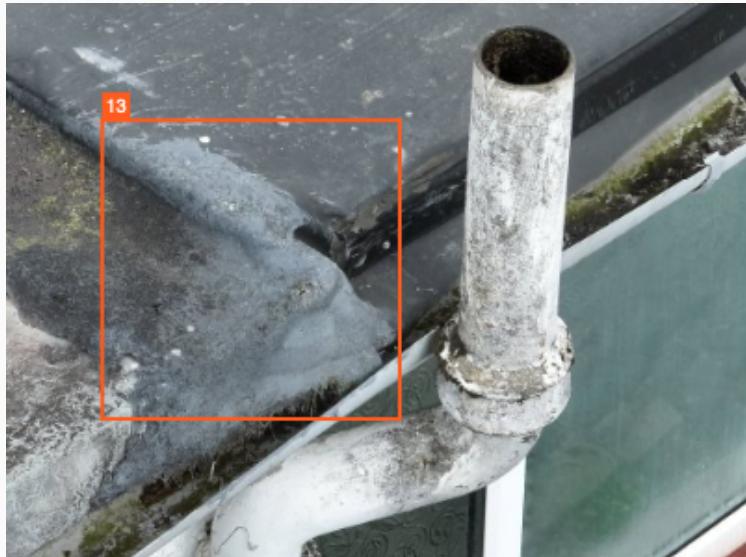
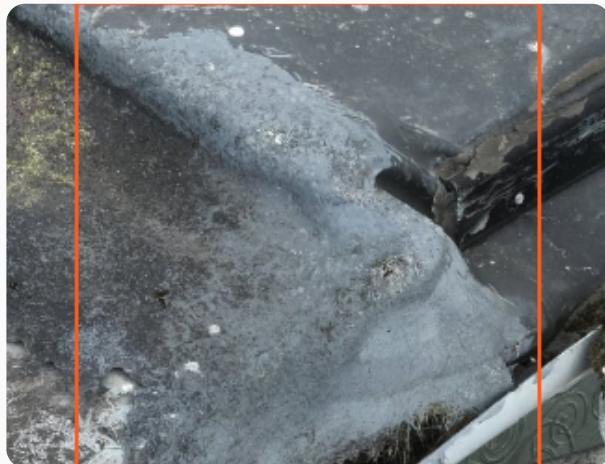
# 13

Severity 3

⚠ Existing repair

**Alex Herman**  
Existing repair

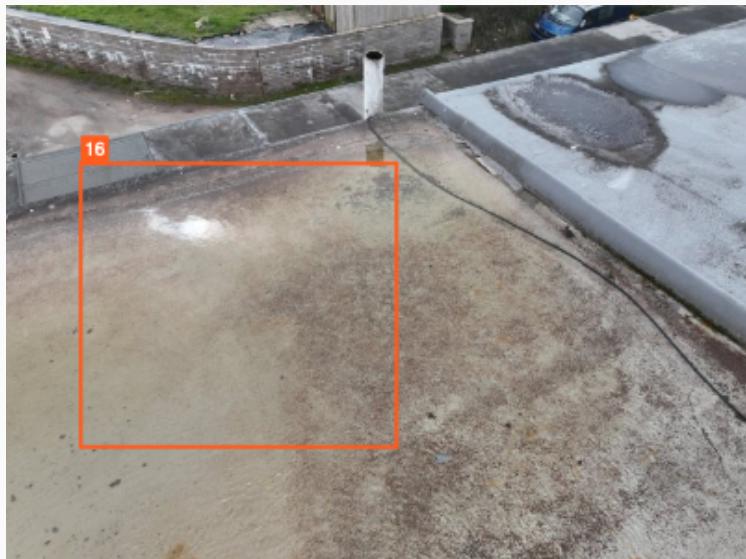
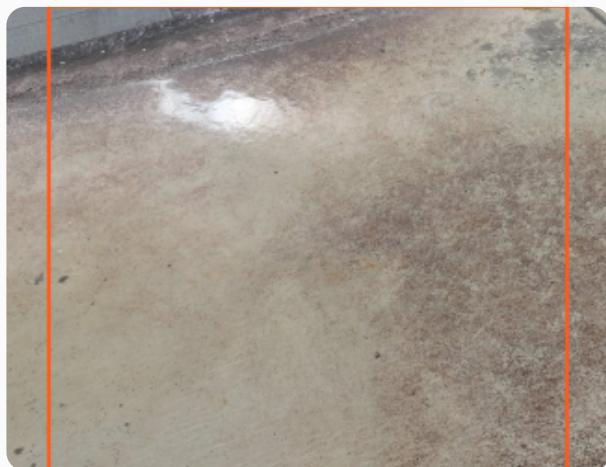
# 16

Severity 3

⚠️ Ponding water

**Alex Herman**  
Ponding water
