# Full View

Aerial Imaging Solutions

## Overview

## Analysis

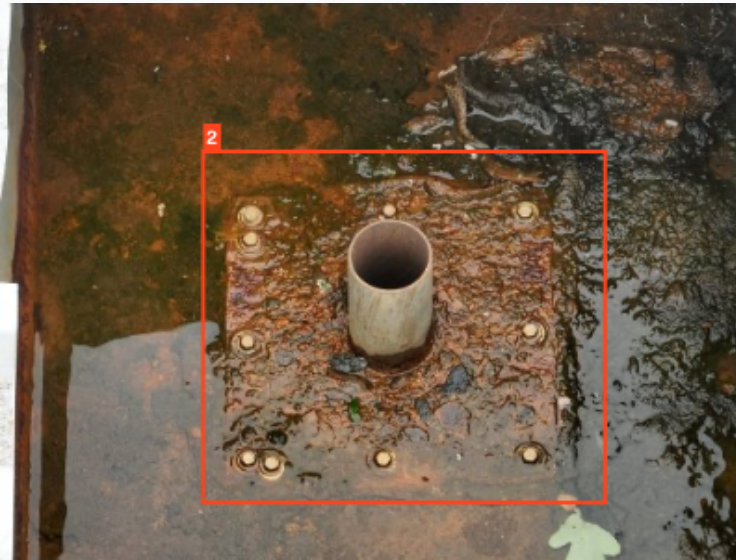
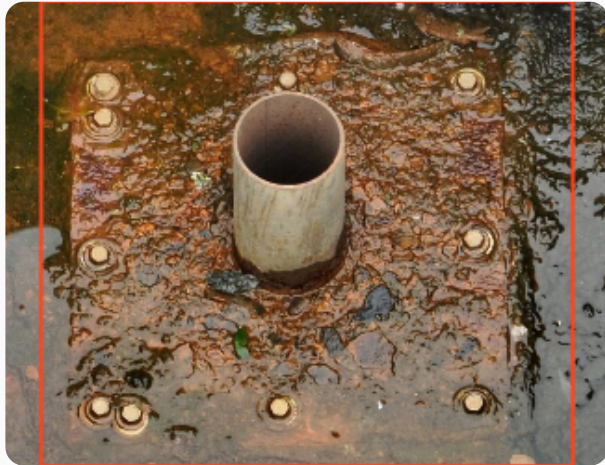
# 2

Severity 4

Gutter corrosion

**Alex Herman**  
Gutter Corrosion

The existing gutter system has significantly deteriorated and is currently in a state of disrepair. A comprehensive program of remedial work is required to restore the system to a safe, functional, and compliant condition.

Following the cleaning process, a detailed internal inspection of the entire gutter system should be conducted. This inspection will focus on identifying areas affected by corrosion and physical damage. In many cases, where the metal substrate is still structurally sound, it may be possible to extend the serviceable life of the gutters by installing a gutter lining system. These systems typically involve the installation of a waterproof membrane that provides long-term protection against leaks and corrosion.

However, if the inspection reveals that certain sections of the guttering are severely corroded—compromising structural integrity or posing safety concerns—those sections will need to be replaced prior to lining. Replacing damaged segments ensures a suitable substrate for the new lining system and guarantees a uniform and reliable outcome across the entire system.

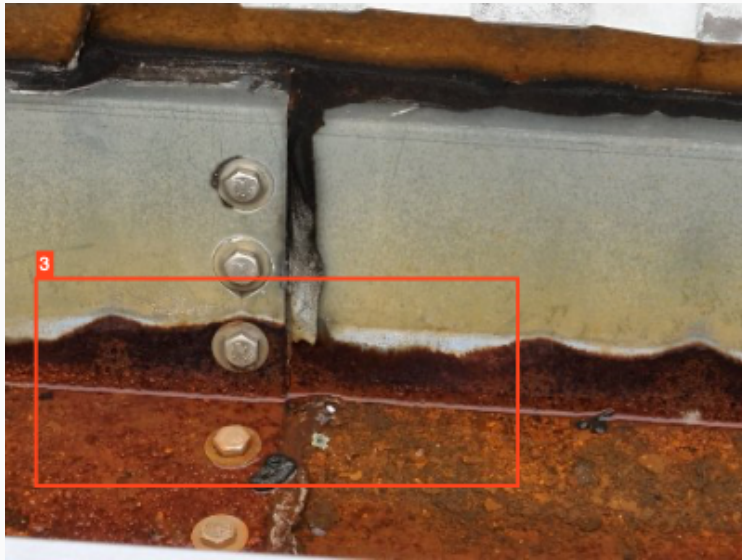
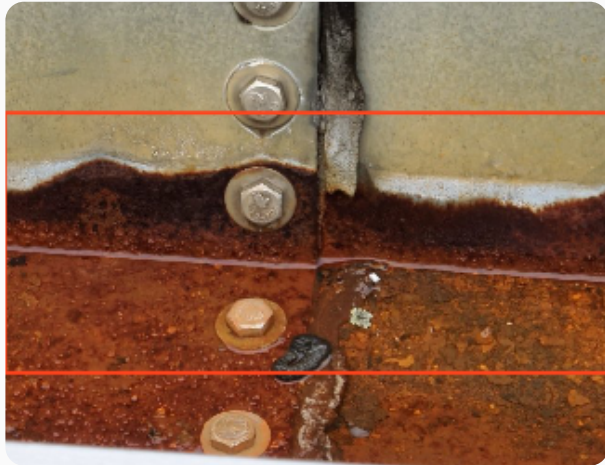
# 3

Severity 4

Gutter corrosion

**Alex Herman**  
Gutter Corrosion

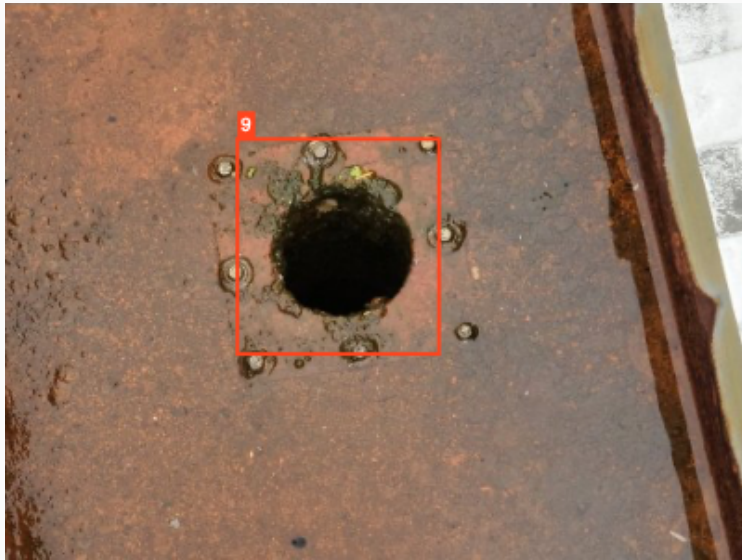
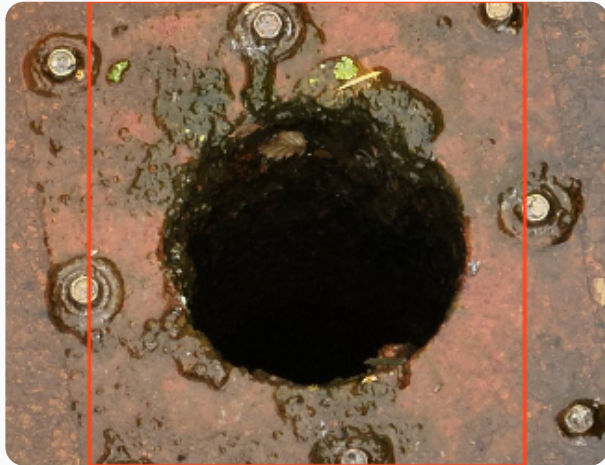
# 9

Severity 4

Gutter corrosion

**Alex Herman**  
Gutter Corrosion

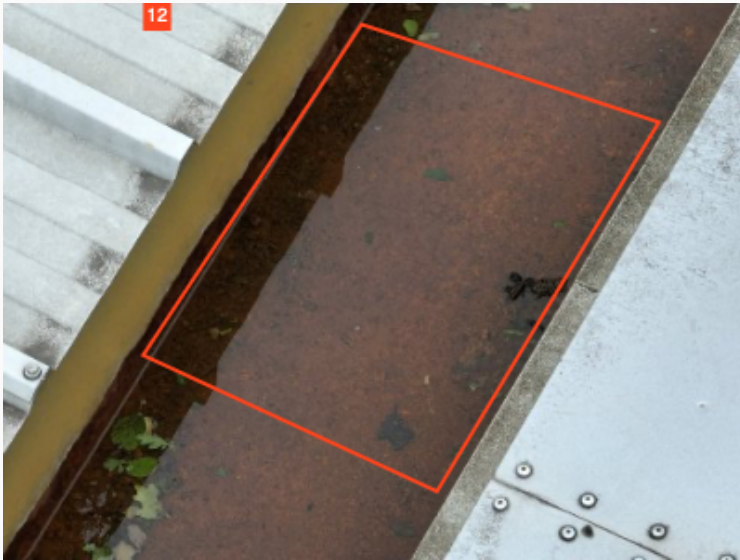
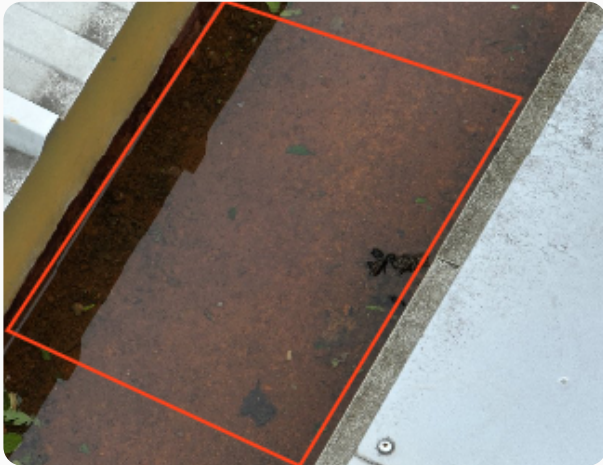
# 12

Severity 4

Ponding water

Ponding water in gutter system

The first step in the restoration process involves the complete removal of all accumulated debris, organic matter, and vegetation from the gutter channels. This is essential to ensure proper water flow and to prevent further deterioration of the gutter surfaces. Once cleared, all associated downpipes must be thoroughly tested using water flow or suitable diagnostic tools to confirm that they are free from blockages or partial obstructions.

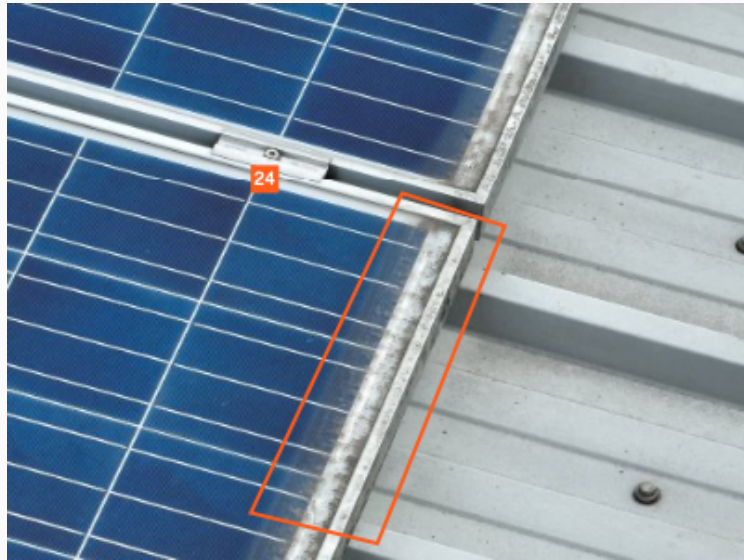
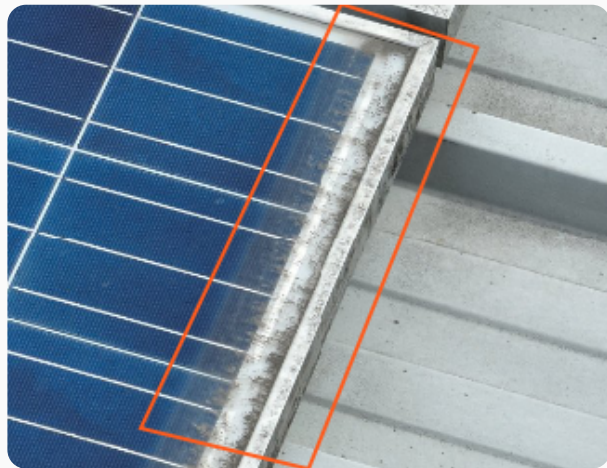
# 24

Severity 3

Debris

Contamination build up on solar PV system
