Aerial Imaging Solutions

Monday 13 July 2026

Re: Report of the overall external roof condition at [REDACTED]

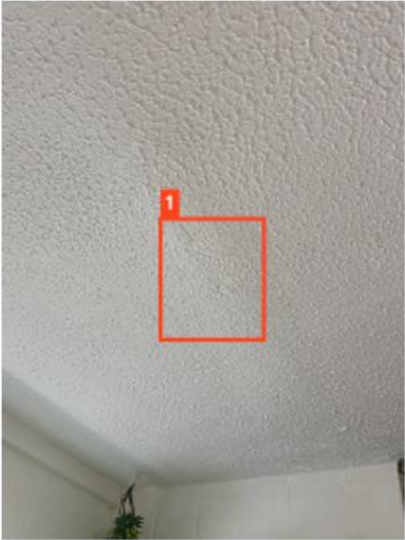
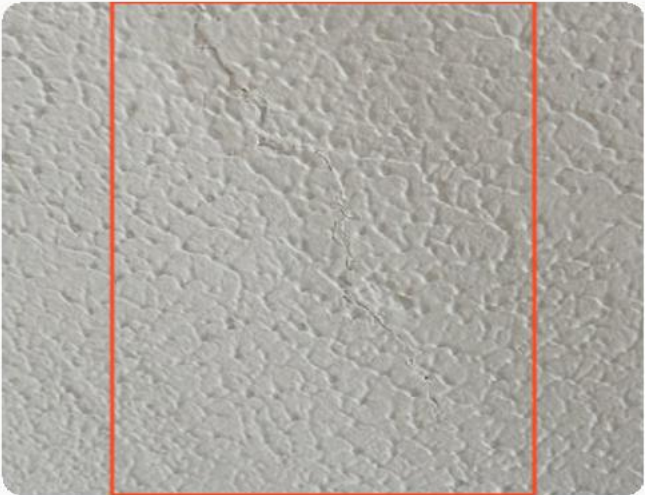
# 1

Severity 4

Water Ingress

**Alex Herman**  
Evidence of water ingress internally

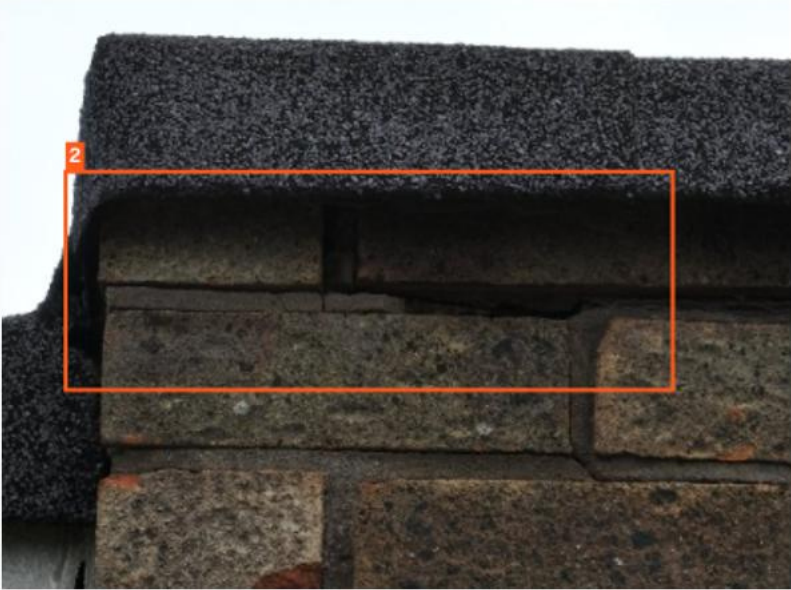
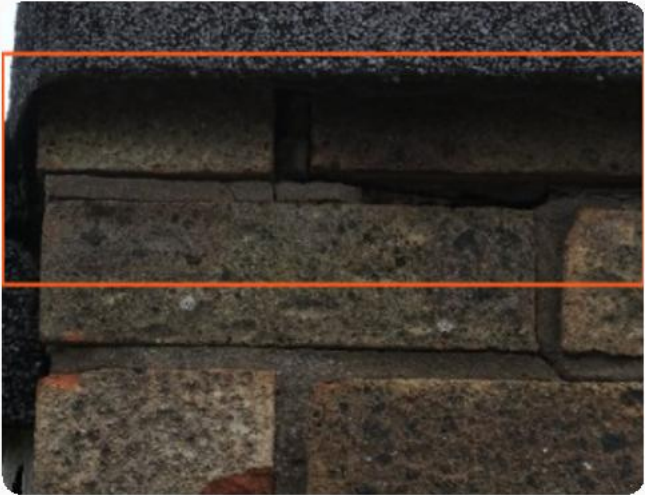
# 2 Severity 3 Mortar Façade

Localised deterioration of the mortar joints was observed within the external brickwork, including areas directly above one of the confirmed locations of internal water ingress. Open or deteriorated mortar joints can permit moisture penetration into the external wall construction, particularly during periods of prolonged or wind-driven rainfall.

**Alex Herman**  
Slight mortar deterioration between  
brickwork

- Rake out all defective mortar joints.
- Repoint the affected masonry using a suitable mortar compatible with the existing construction.
- Inspect adjacent elevations for further areas of mortar deterioration and undertake localised repairs where necessary.

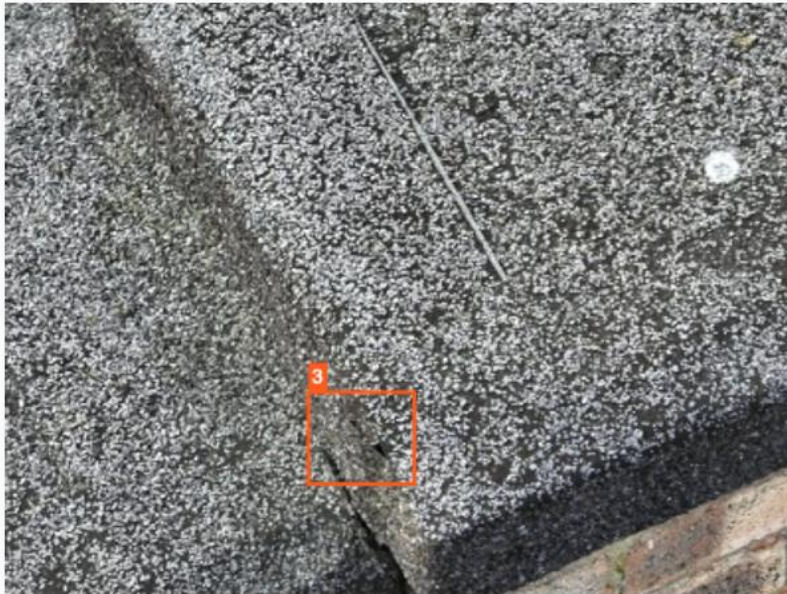
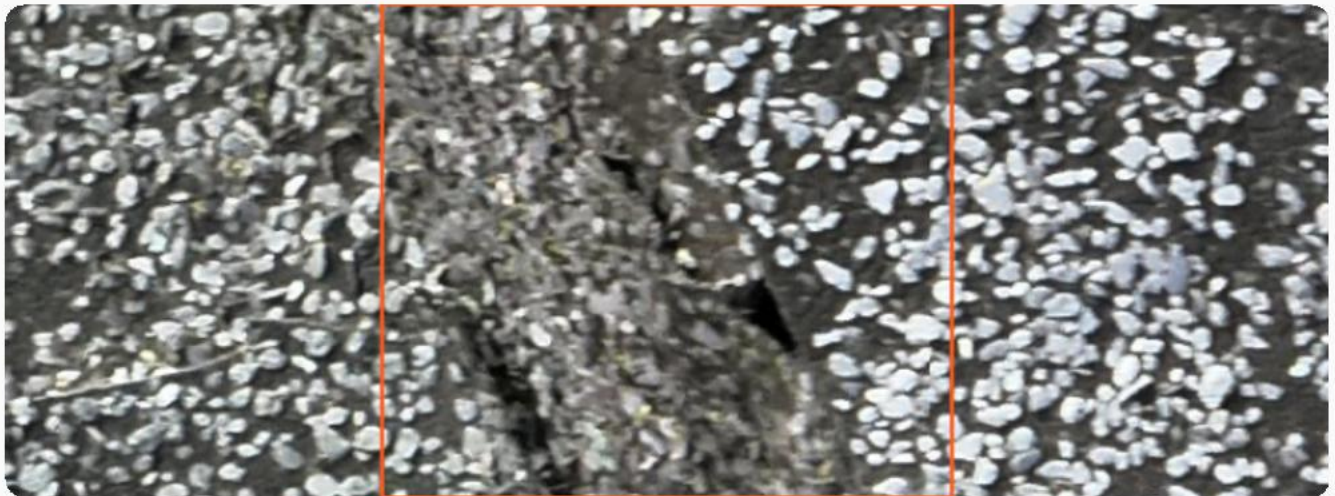
# 3

Severity 3

Felt roof lap failure

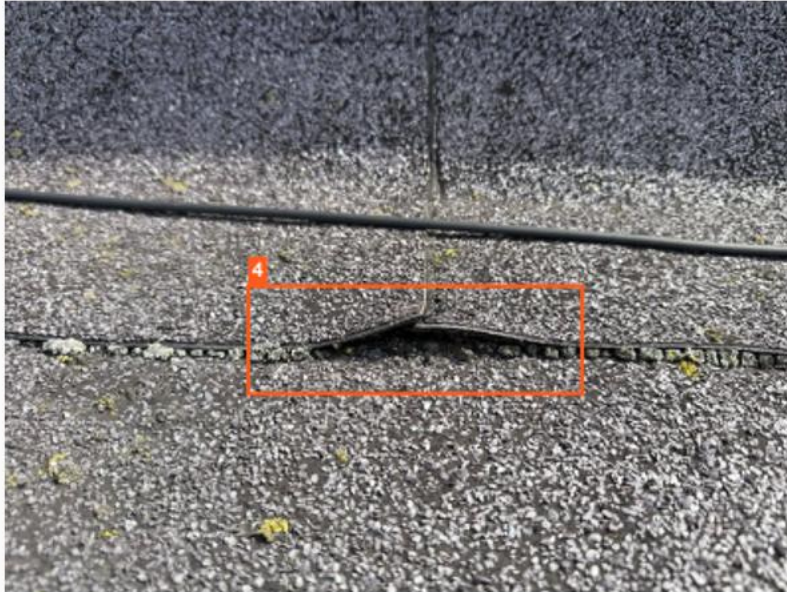
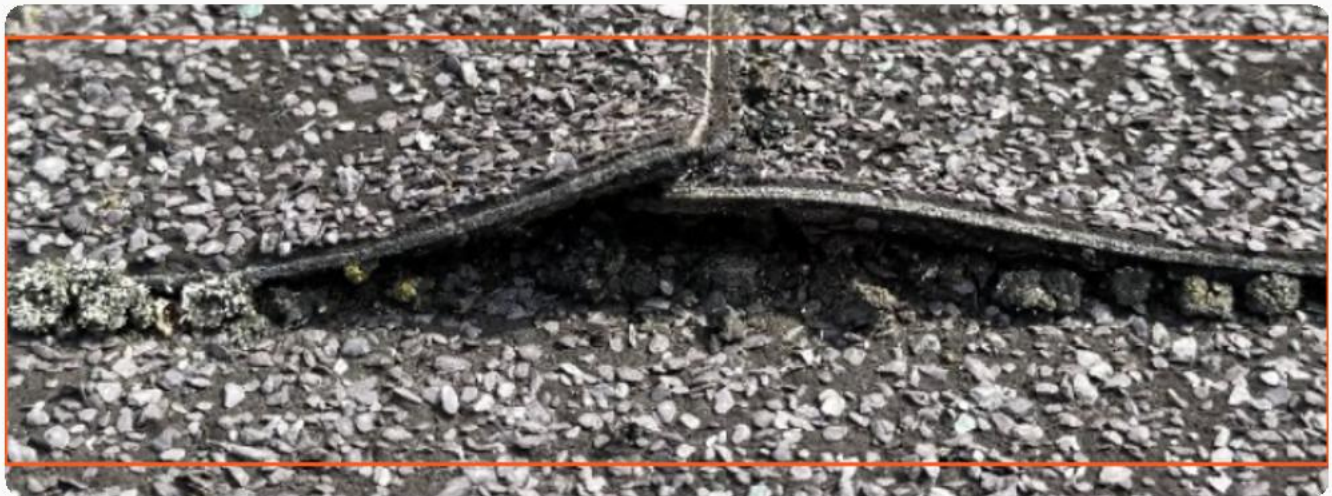
# 4

Severity 3

Felt roof lap failure

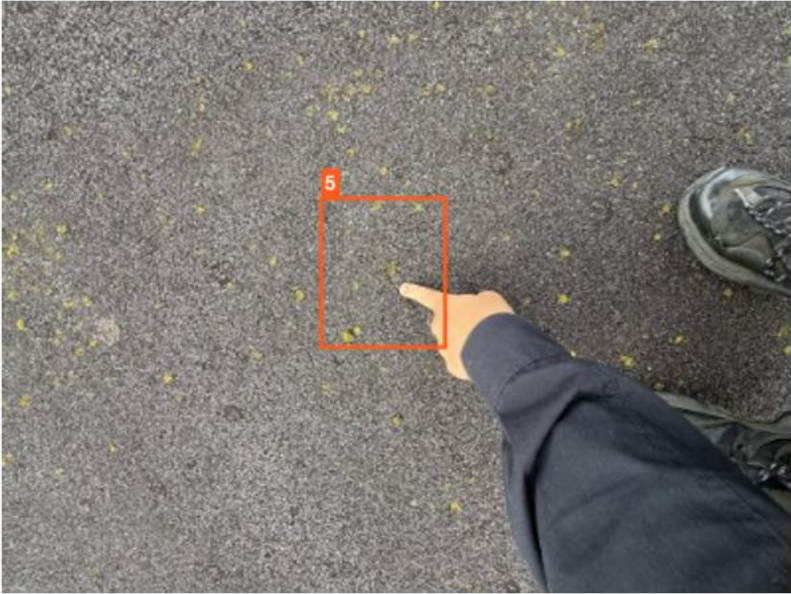
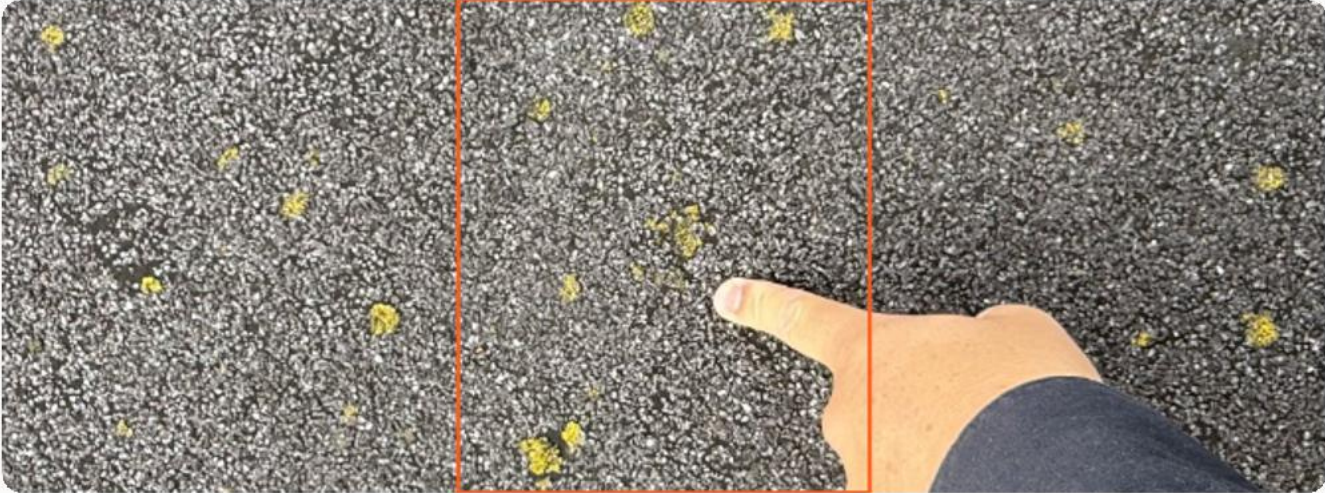
# 5

Severity 3

bubbling

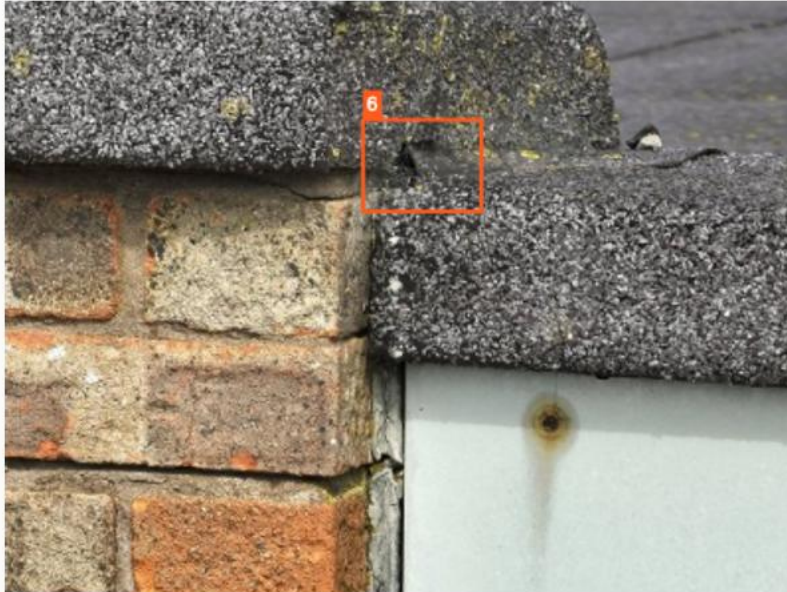
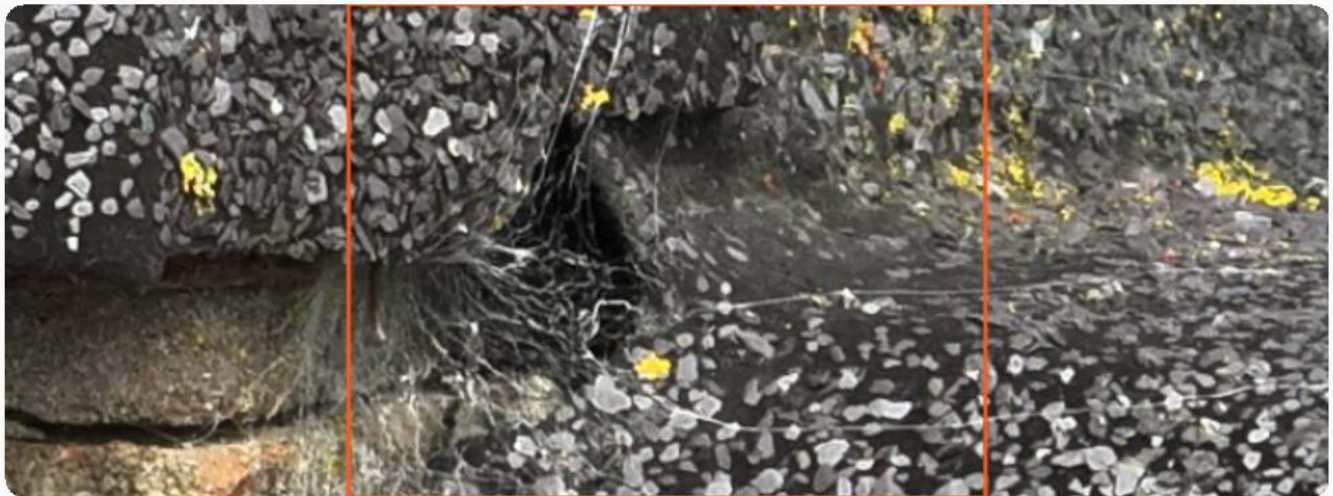
# 6

Severity 3

Felt roof lap failure

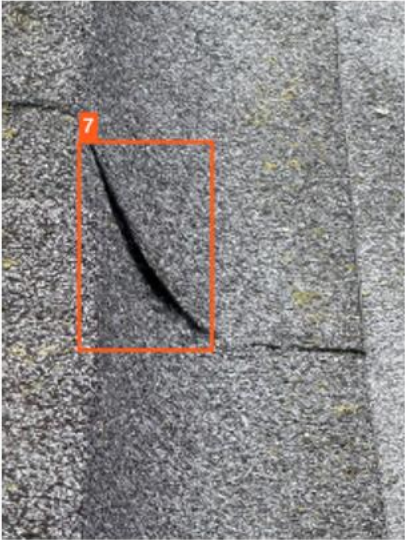
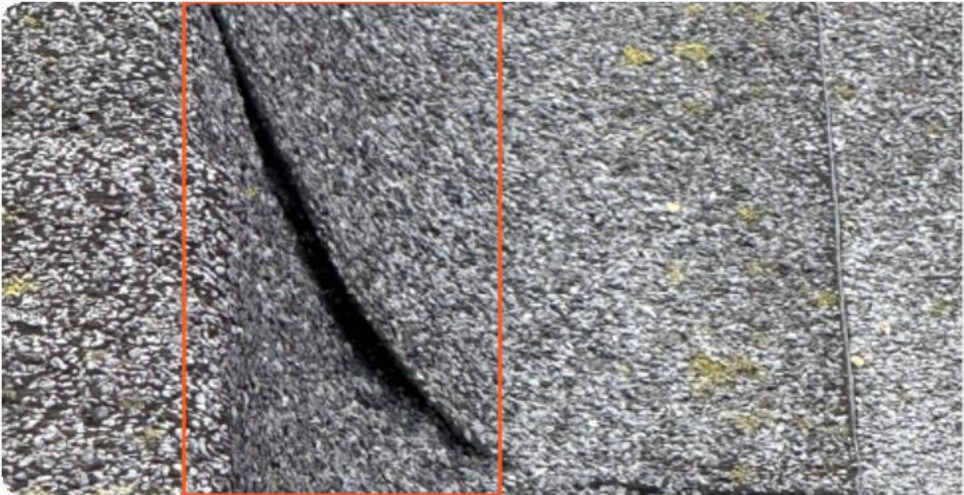
# 7

Severity 3

Felt roof lap failure

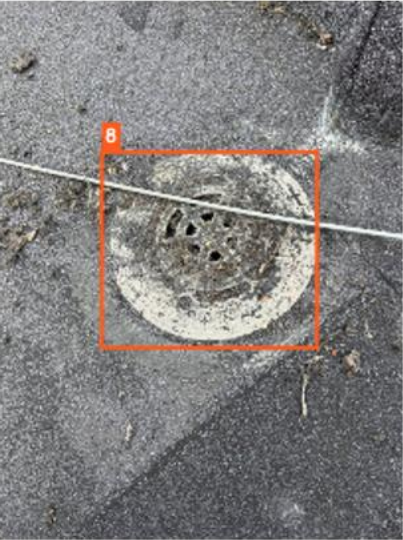
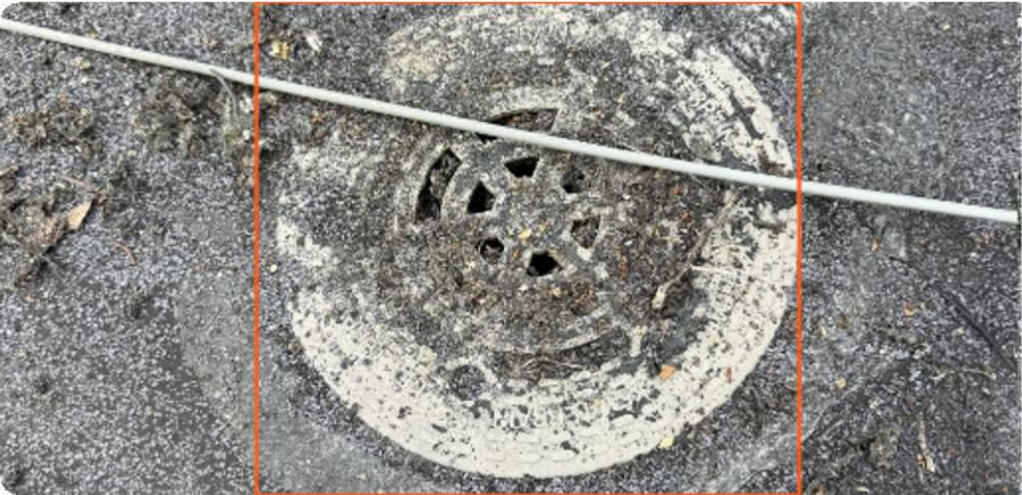
# 8

Severity 3

Debris

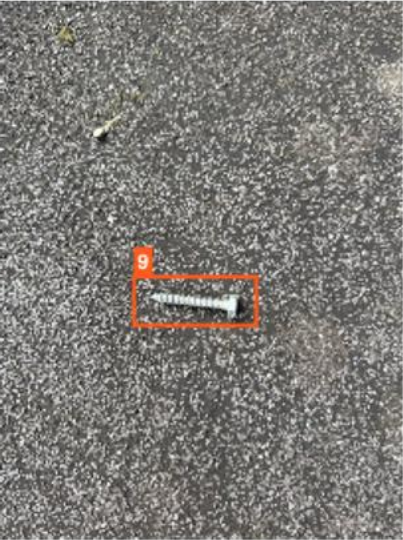
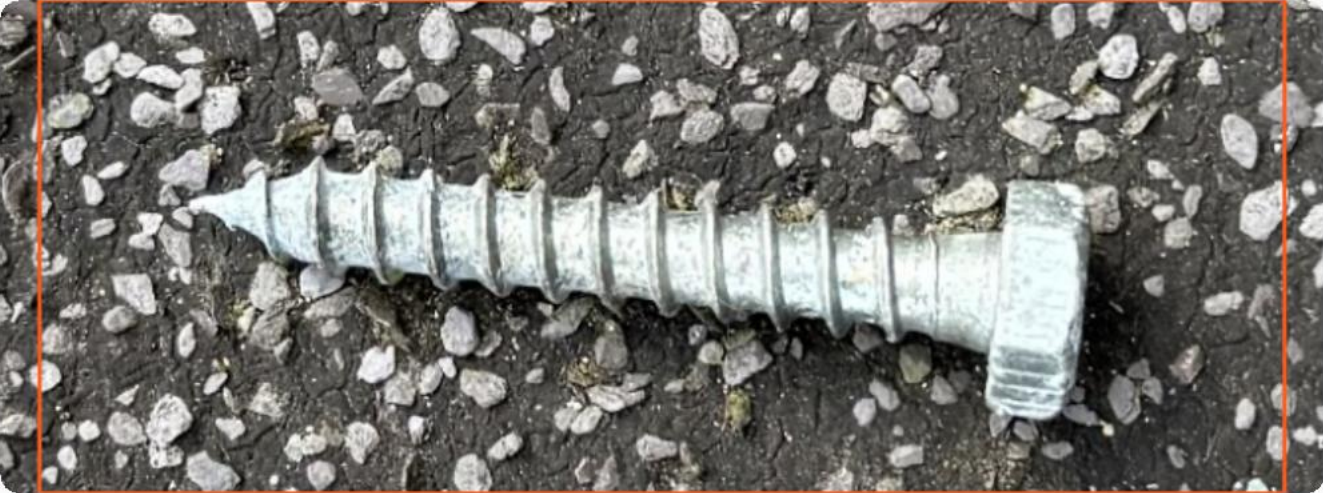
# 9

The roof surfaces are also poorly maintained, with debris and vegetation present throughout. Particular concern is noted regarding the accumulation of loose screws and other debris, which may impede surface water drainage, increase the likelihood of puncturing the roof membrane, and accelerate deterioration if left in place.

Severity 3

Debris

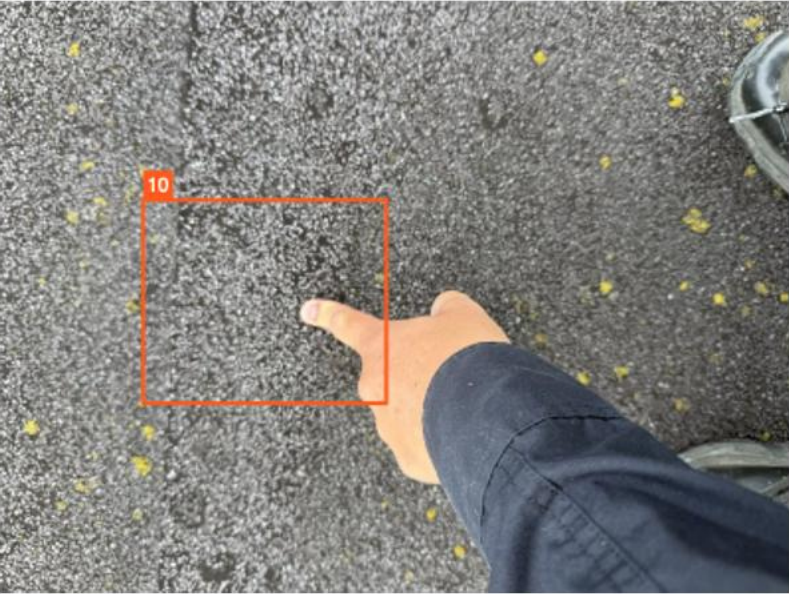
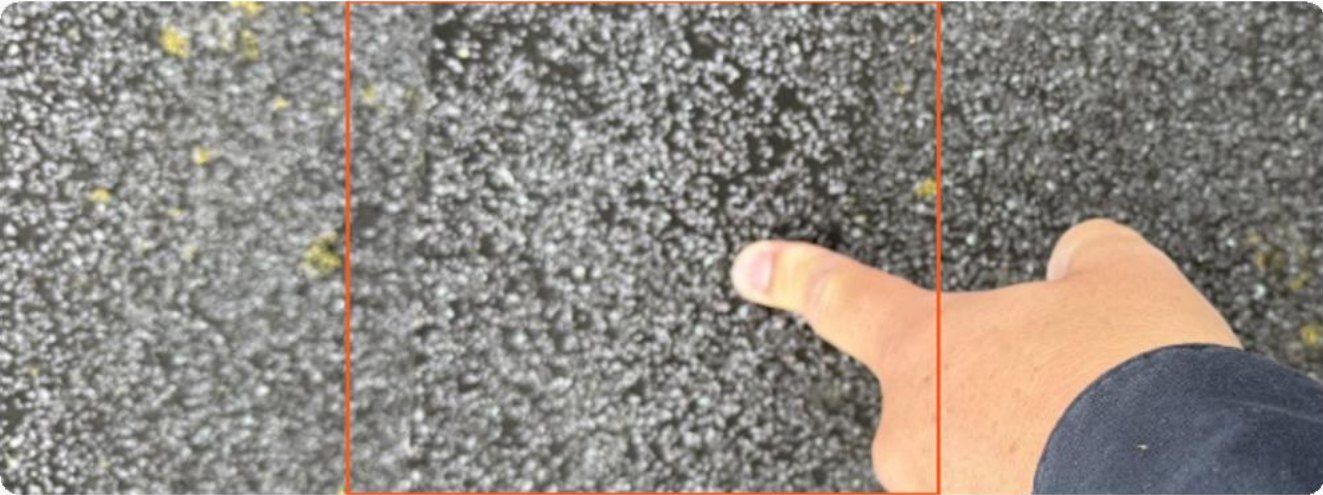
# 10

Severity 3

bubbling

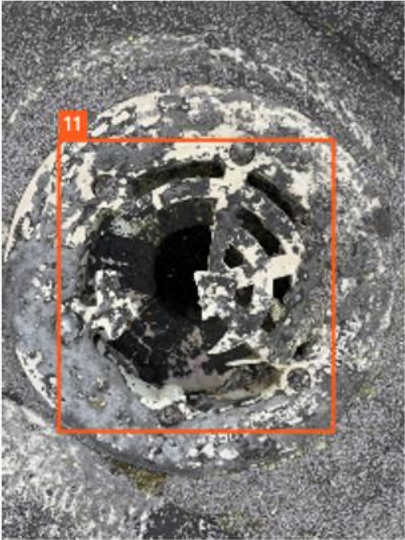
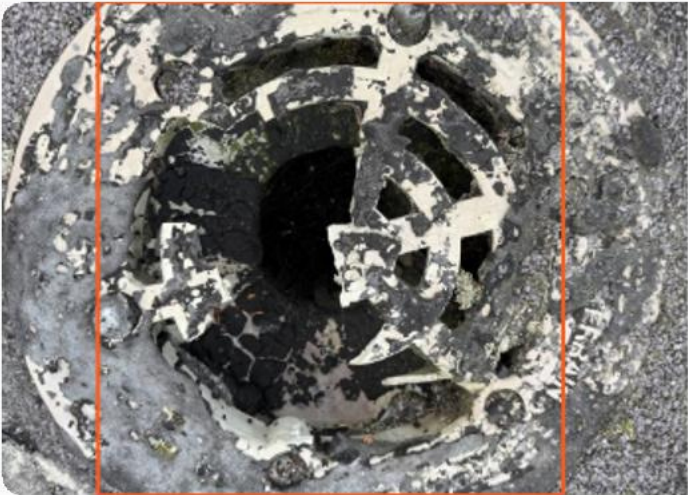
# 11

Severity 3

Missing leaf guard

- Replace all missing and damaged leaf guards.
- Remove all debris from the roof drainage outlets.
- Test and inspect all downpipes to confirm they are free from obstruction and operating correctly.
- Clean and flush the complete rainwater drainage system.
- Repair any defects identified during testing.

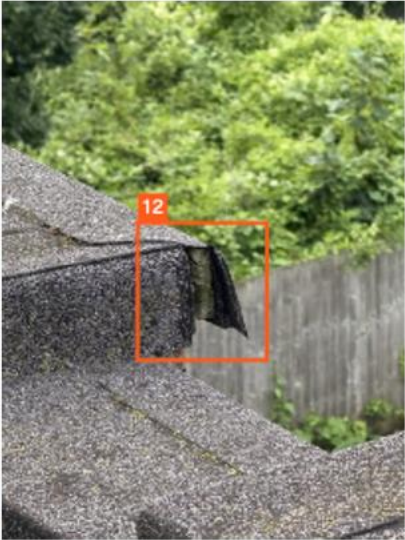
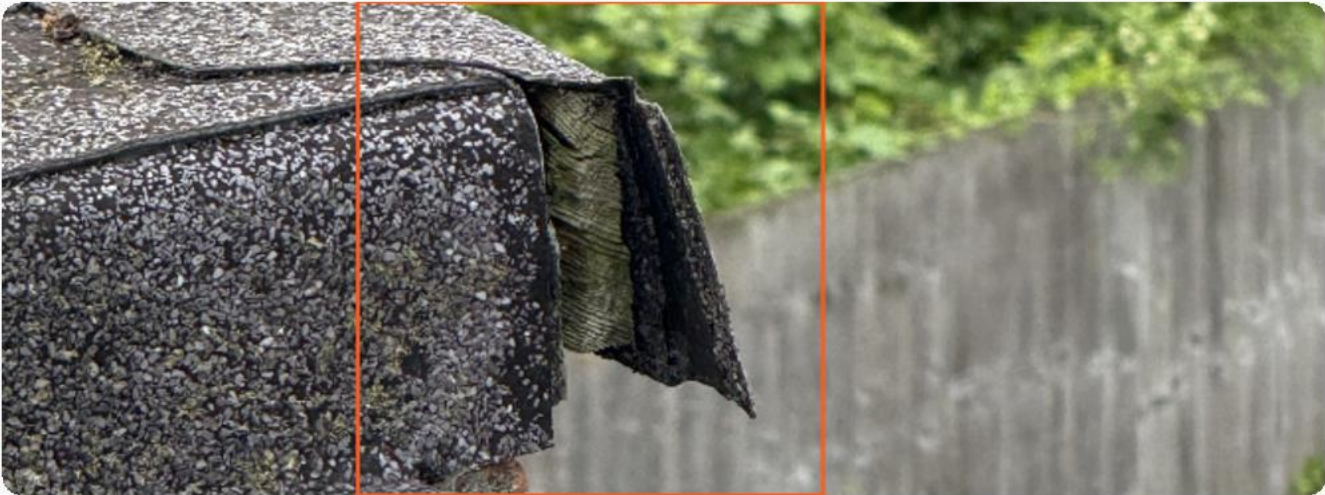
# 12

Severity 3

Felt roof lap failure

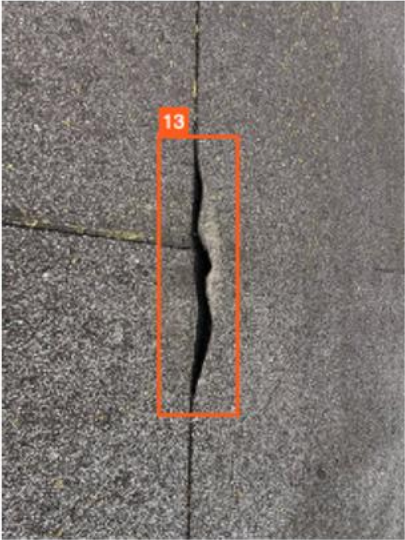
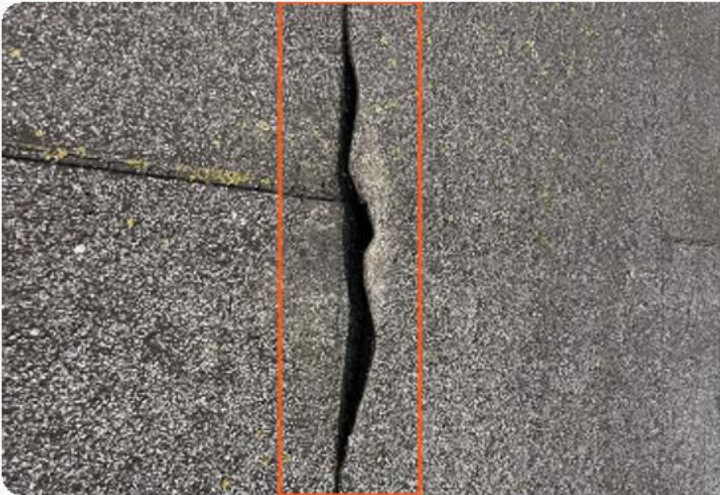
# 13

Severity 3

Felt roof lap failure

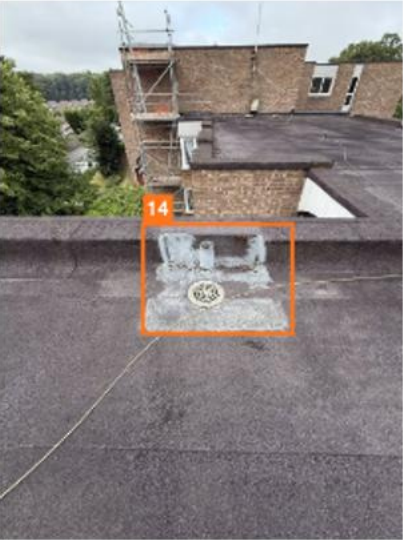
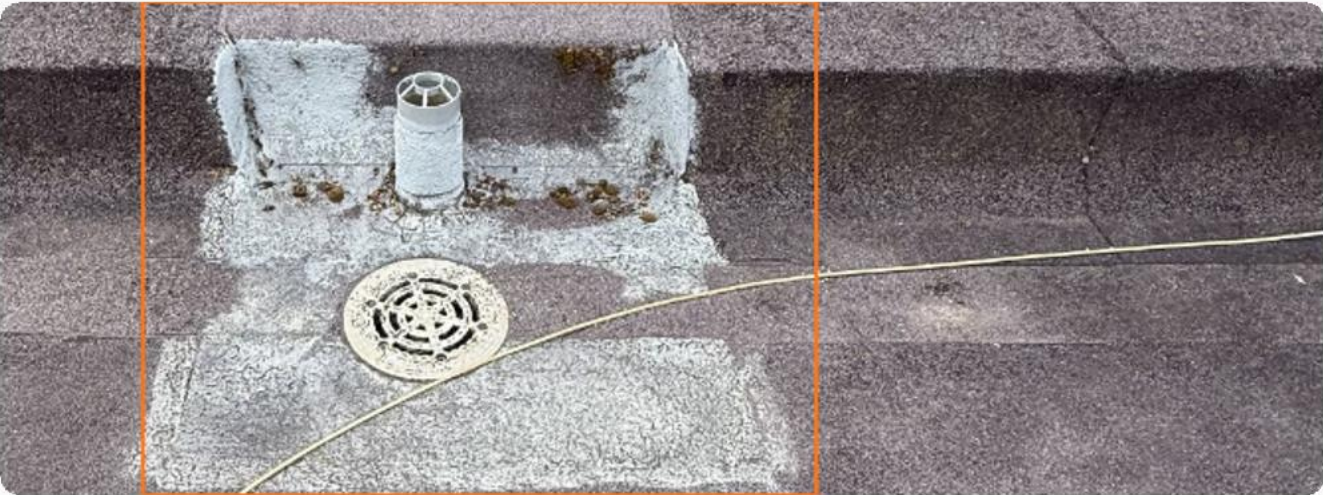
# 14

Severity 2

Existing repair

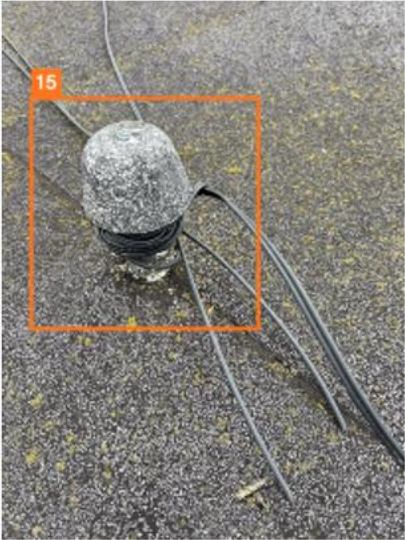
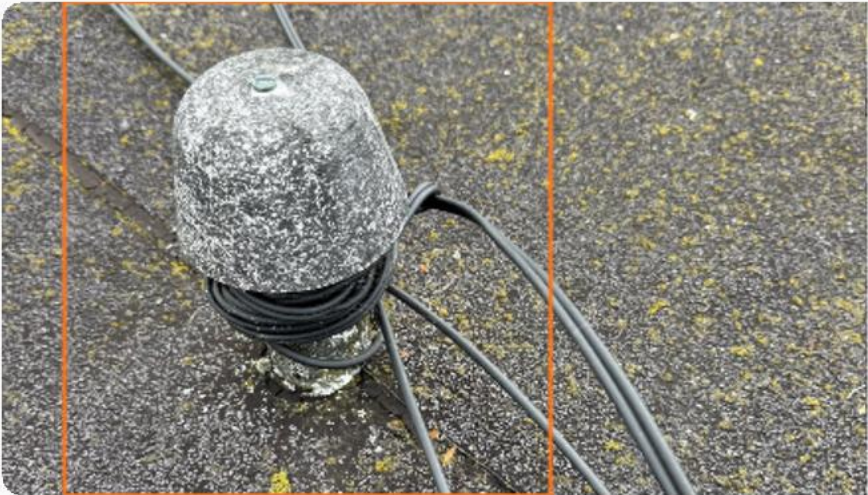
# 15

Redundant electrical cabling has been secured to soil vent pipes (SVPs). This installation is not considered good practice and serves no operational purpose. The redundant cabling should be removed as part of the maintenance works to eliminate unnecessary loading on the vent pipes and improve general roof housekeeping.

Severity 2

Cabling

- Remove all redundant cabling from the roof.
- Inspect the remaining roof-mounted services to ensure they are adequately supported and do not compromise the roof covering.

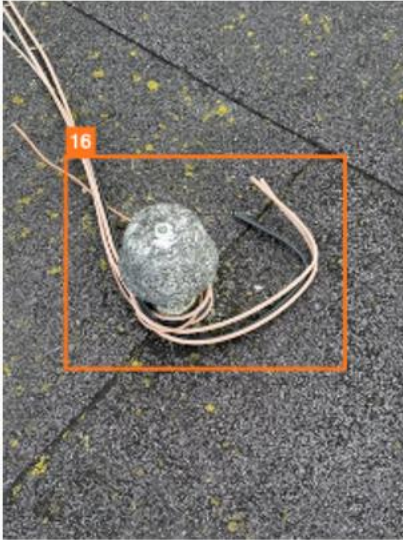
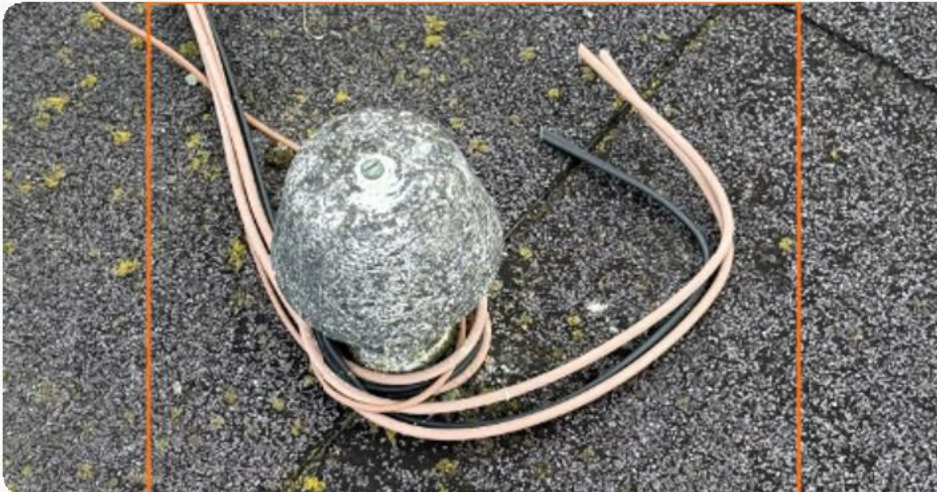
# 16

Severity 2

Cabling

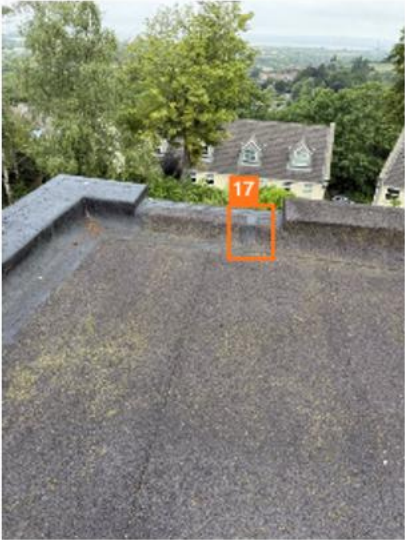
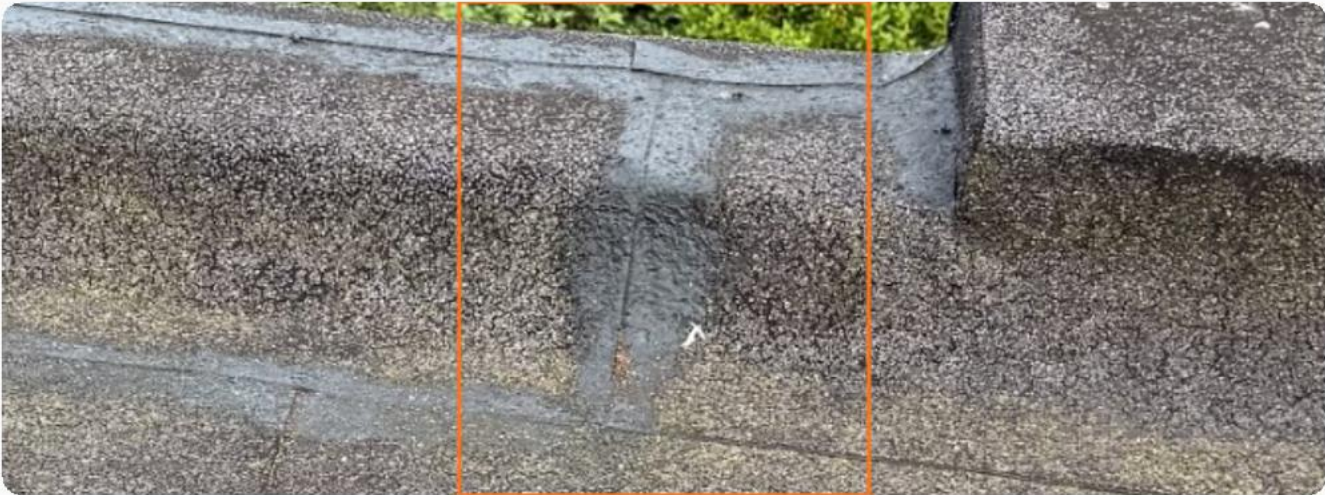
# 17

Severity 2

Existing repair

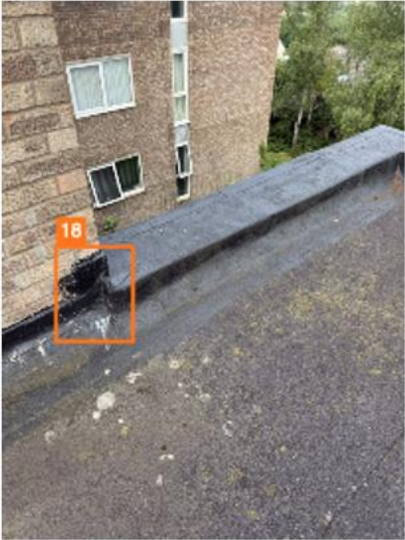
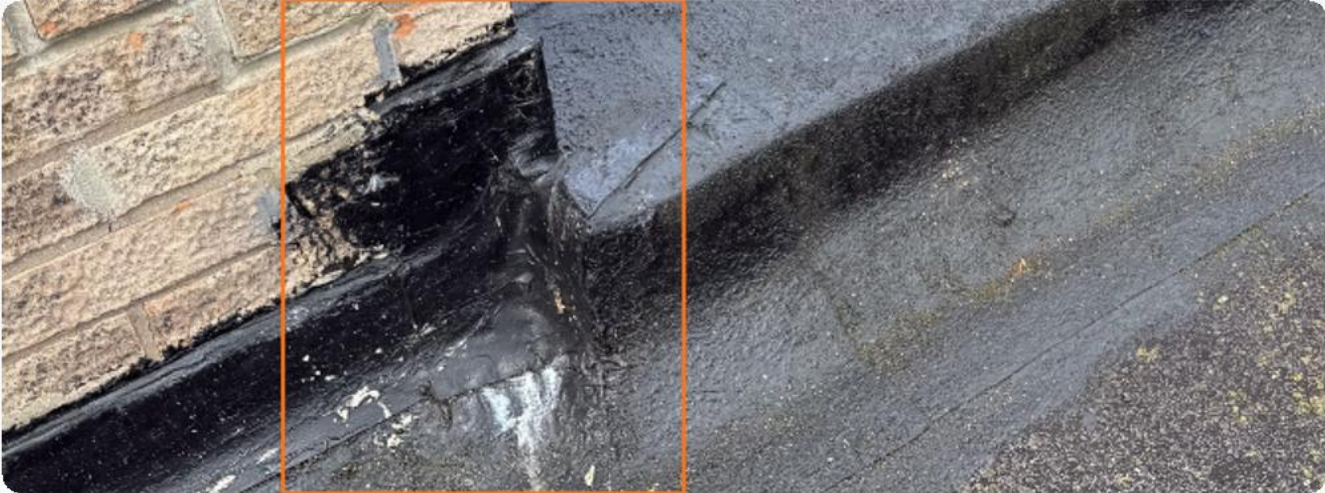
# 18

Severity 2

Existing repair

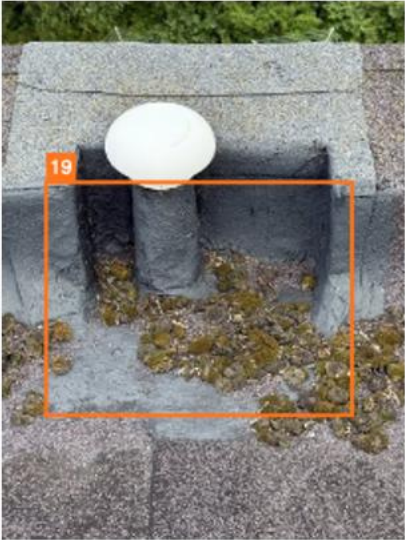
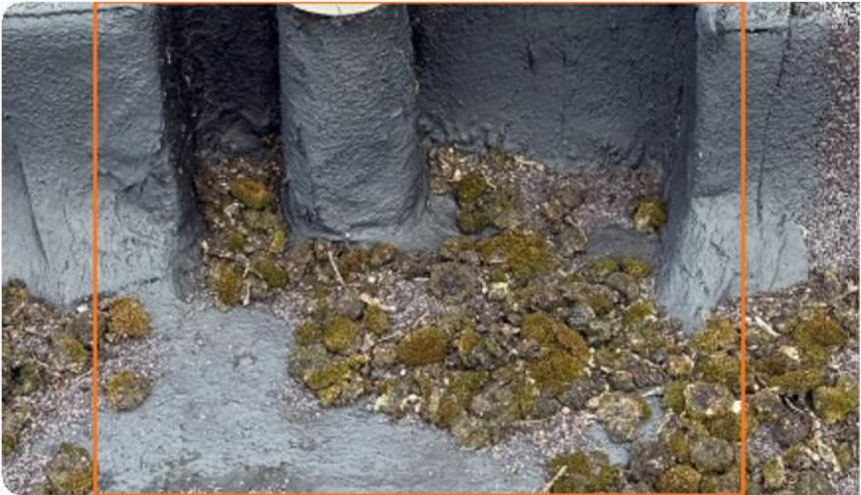
# 19

Severity 2

Existing repair

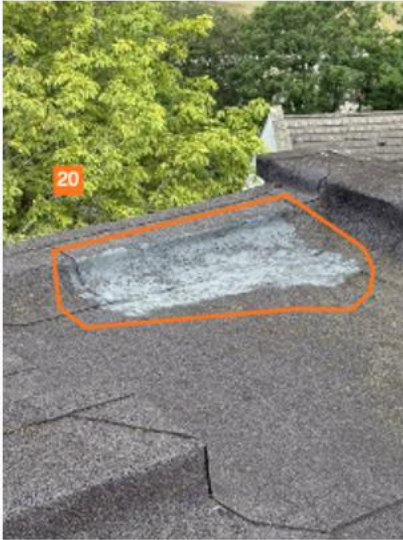
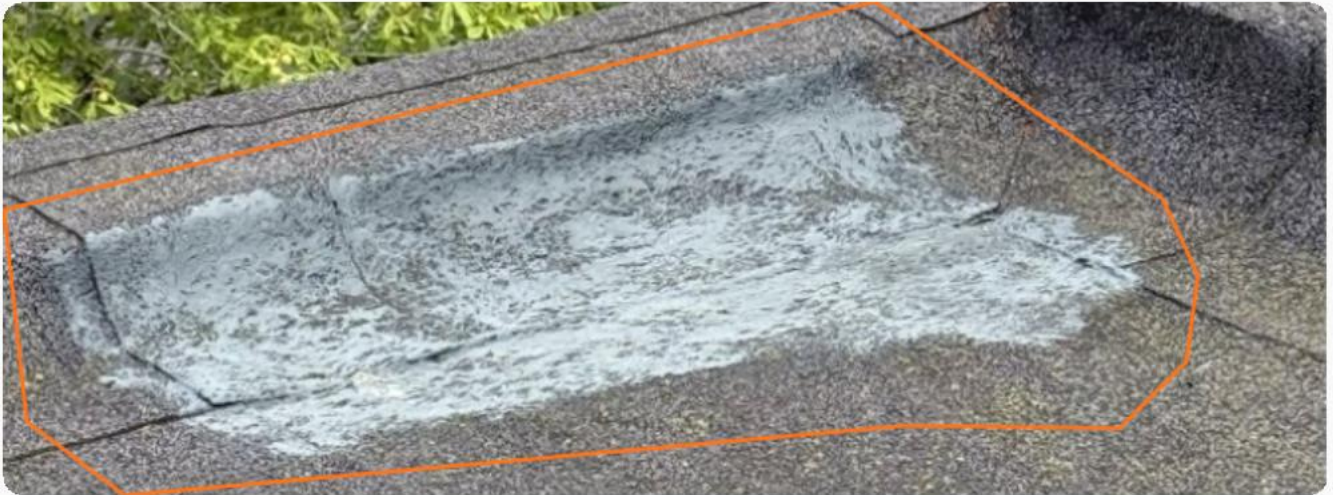
# 20

Severity 2

Existing repair

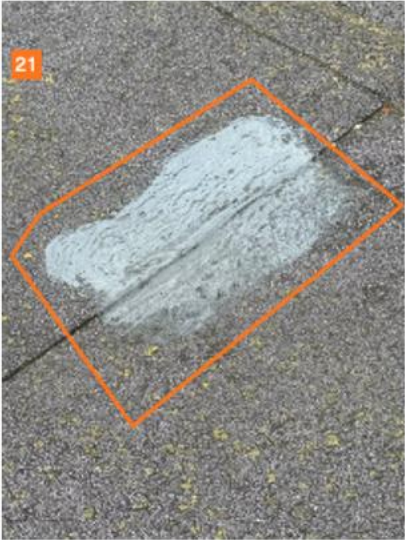
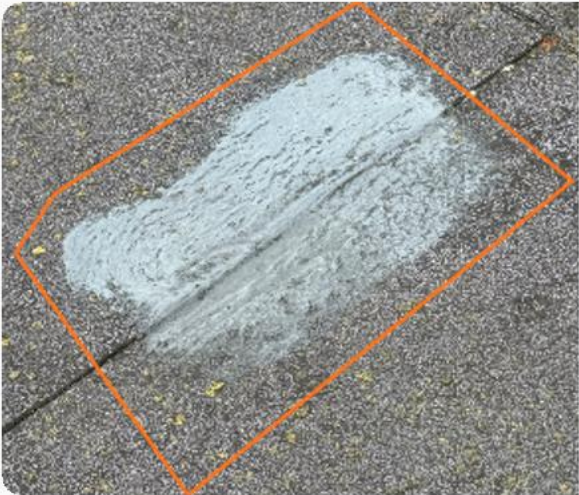
# 21

Severity 2

Existing repair

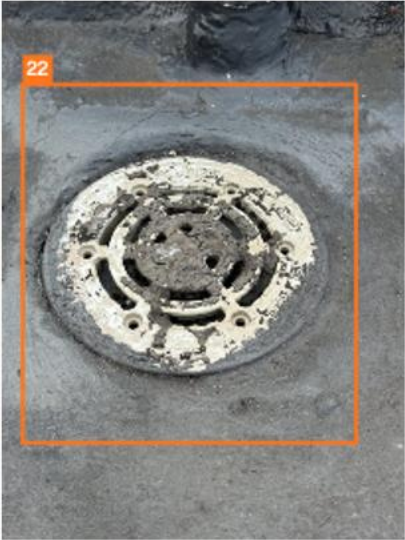
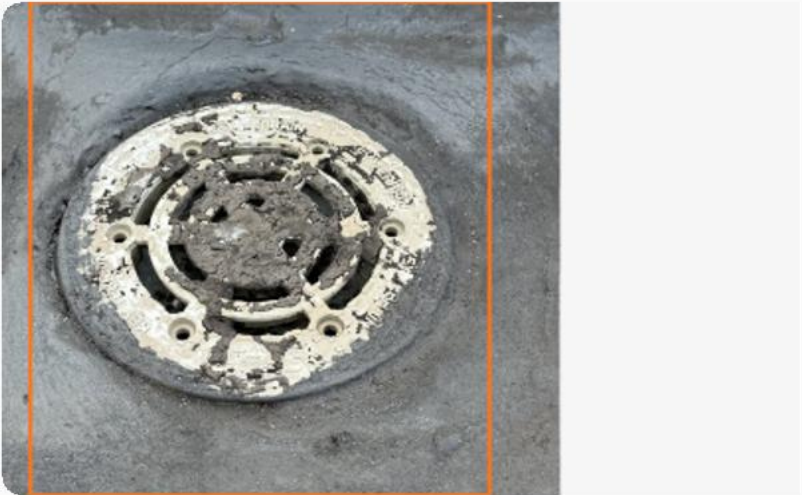
# 22

Severity 2

Existing repair

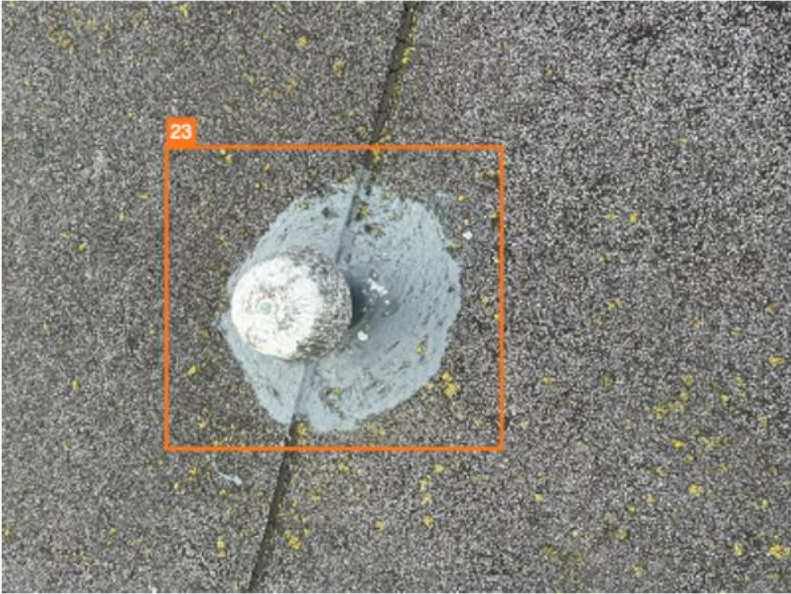
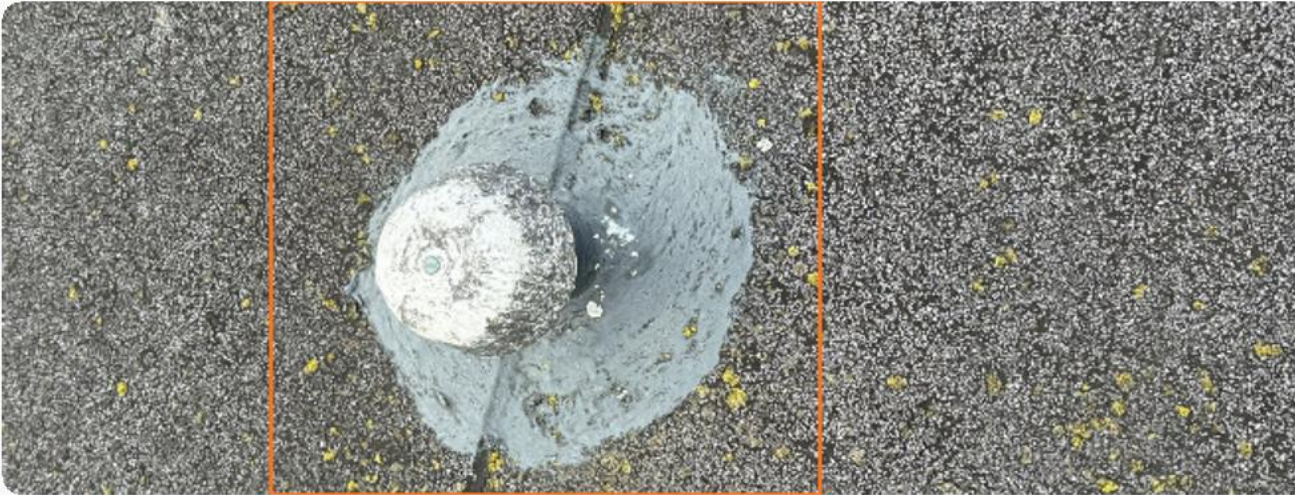
# 23

Severity 2

Existing repair

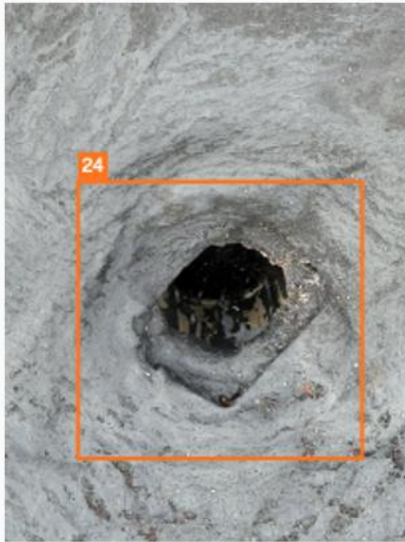
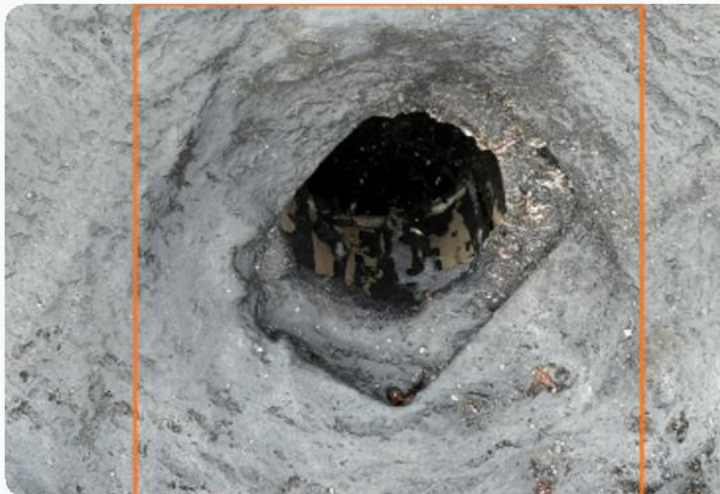
# 24

Severity 2

Missing leaf guard

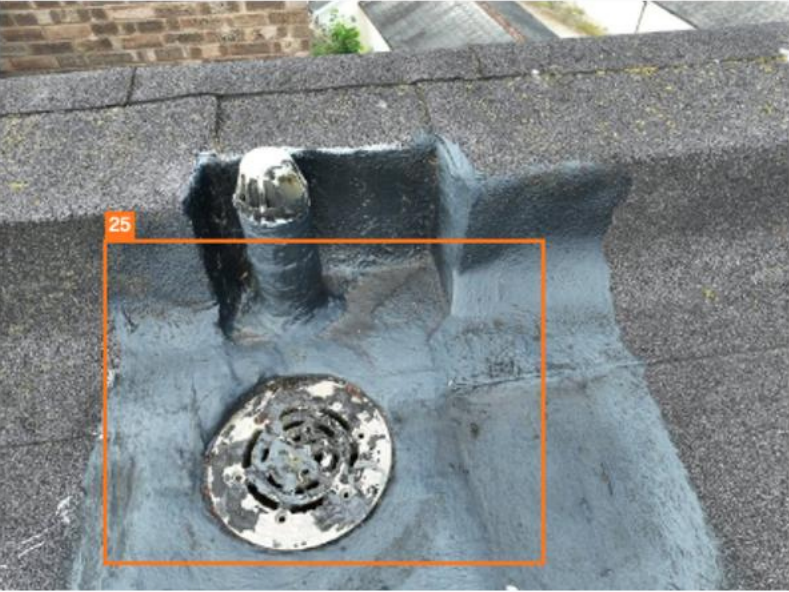
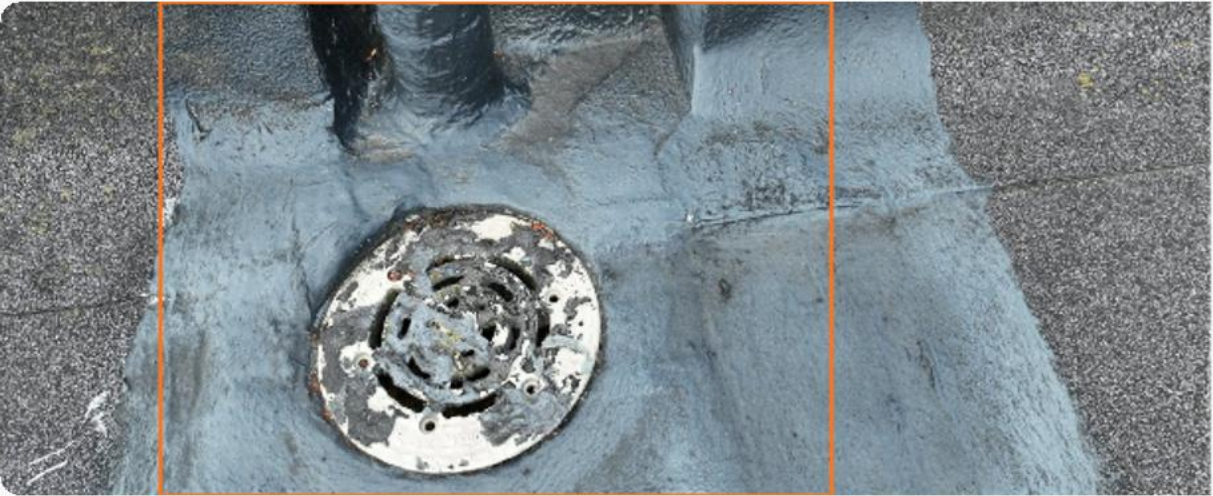
# 25

Severity 2

Existing repair

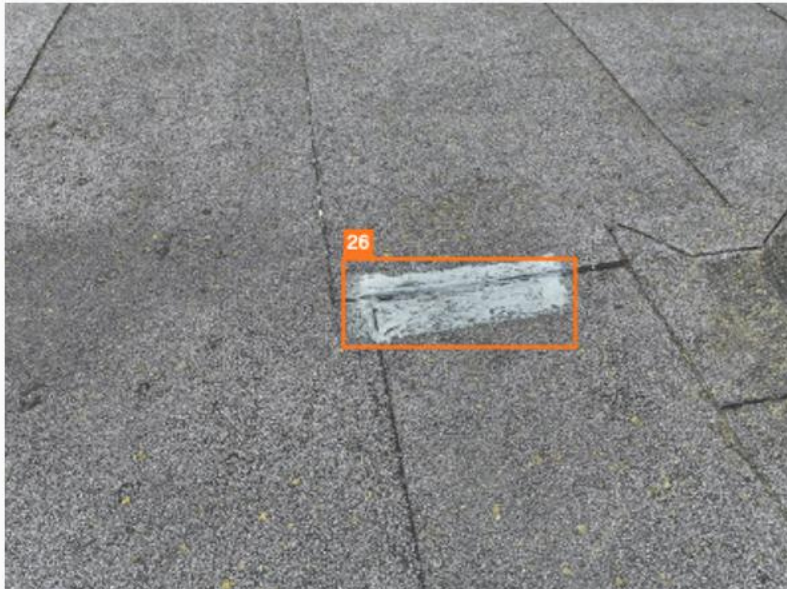
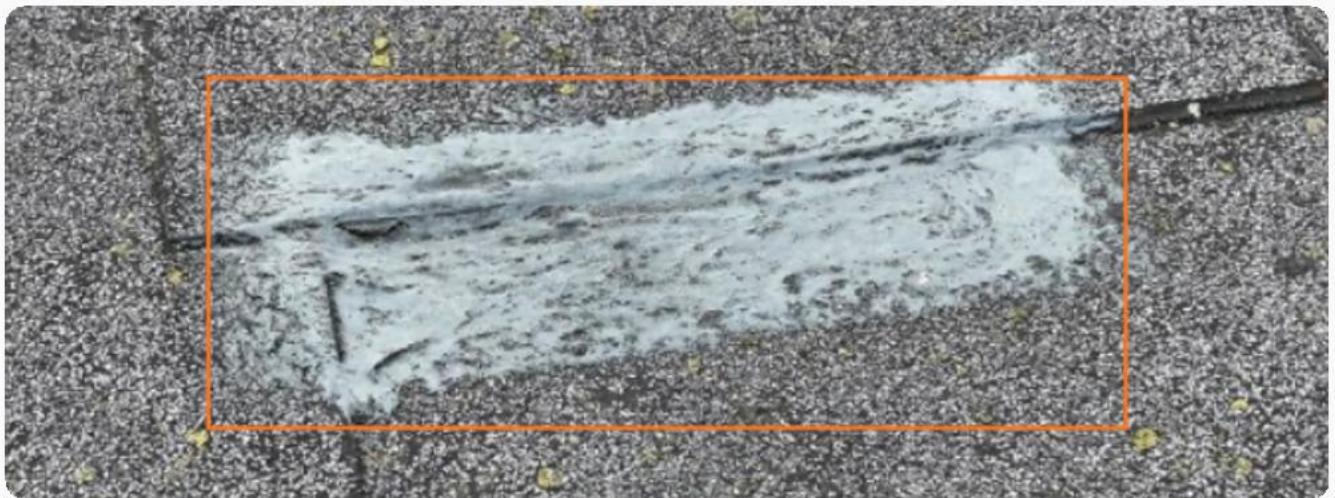
# 26

Severity 2

Existing repair
