Aerial Imaging Solutions

Monday 13 July 2026

Re: Report of the overall external roof condition at [REDACTED]

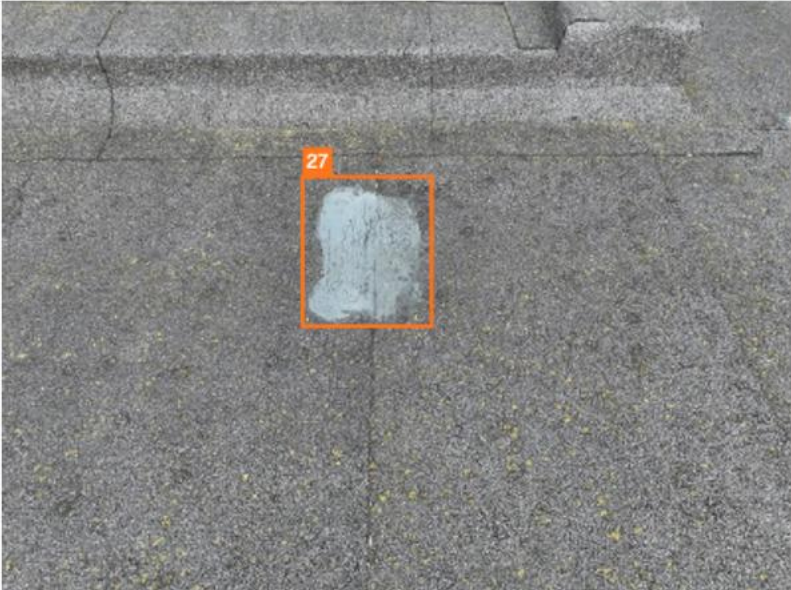
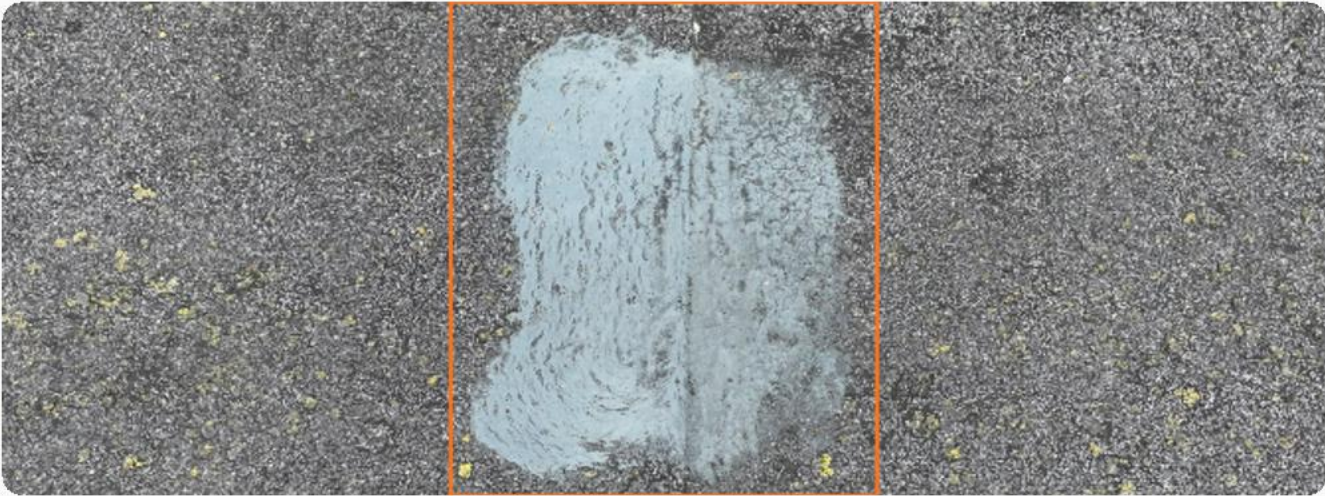
# 27

Severity 2

Existing repair
