Re: Report of the vertical facades of

Please see below a full facade survey of the above named property.

We have been instructed to perform an inspection of the vertical facades using a drone to identify defects.

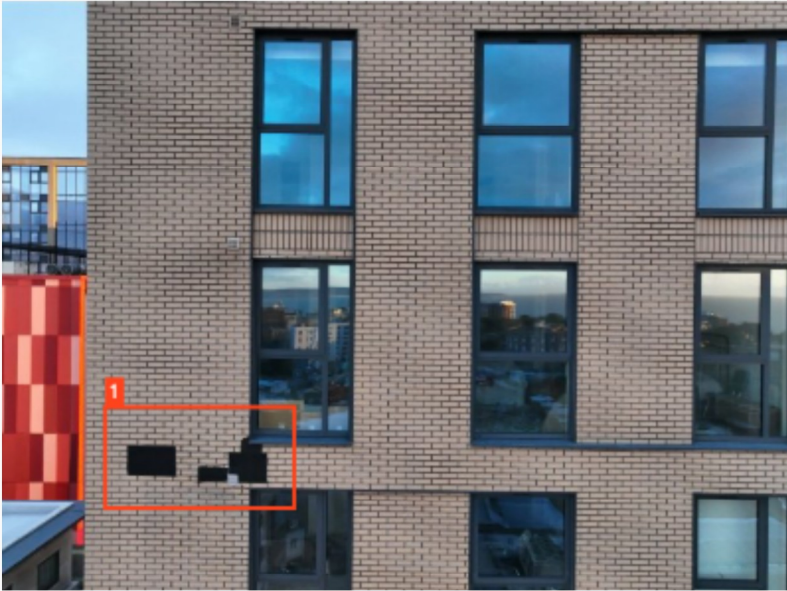
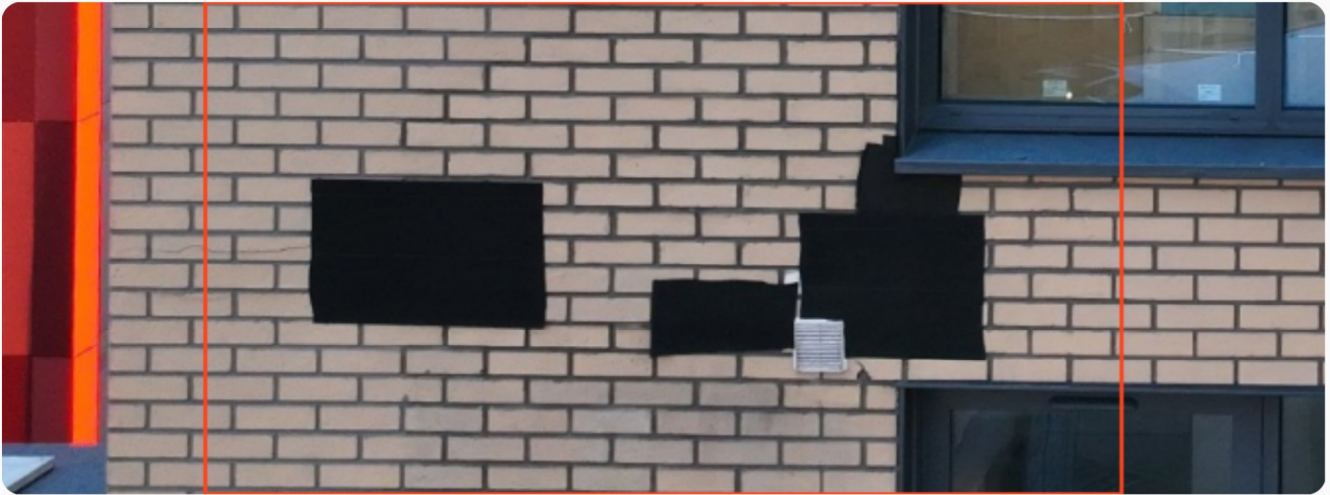
1

Severity 4

Damage

Cladding

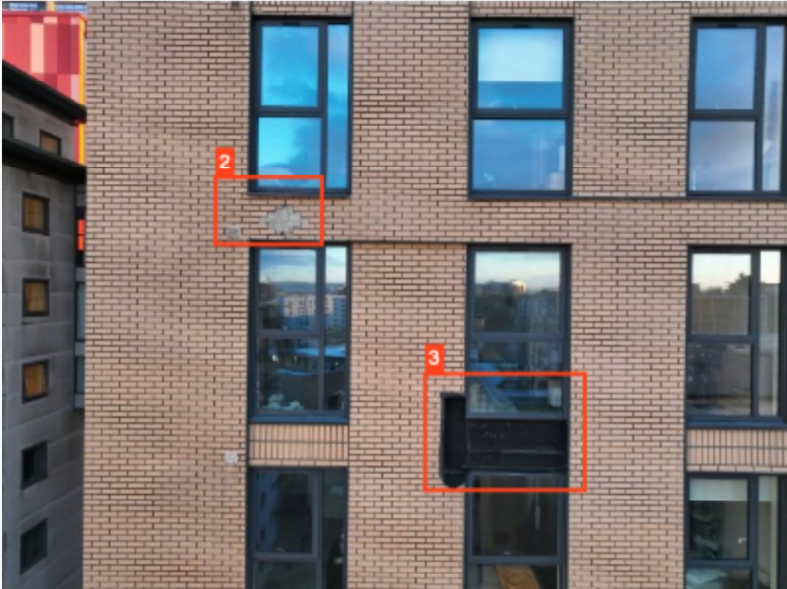
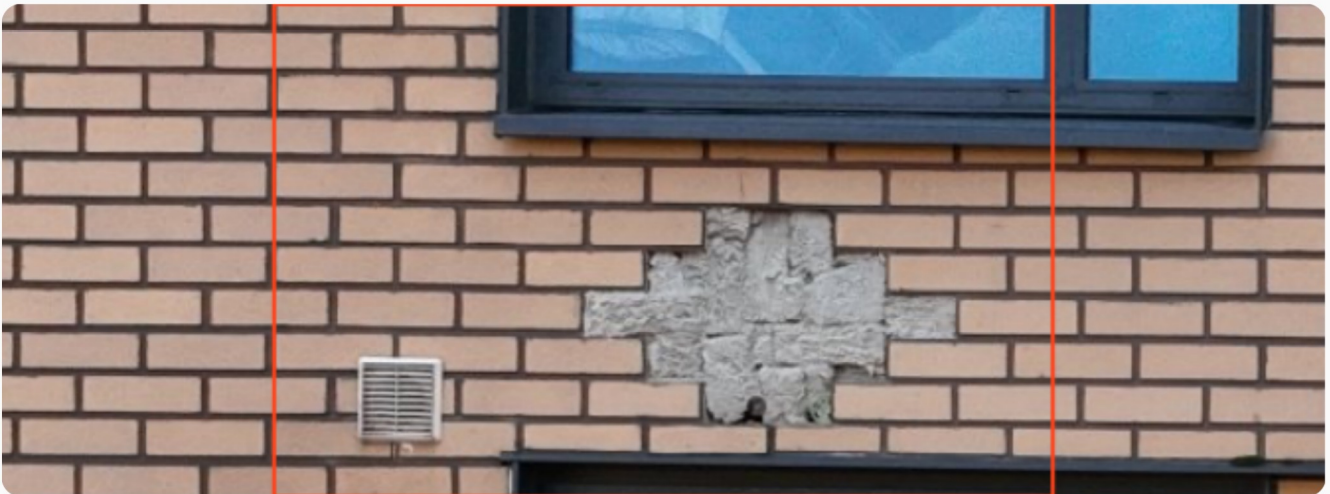
2

Severity 4

Damage

Cladding

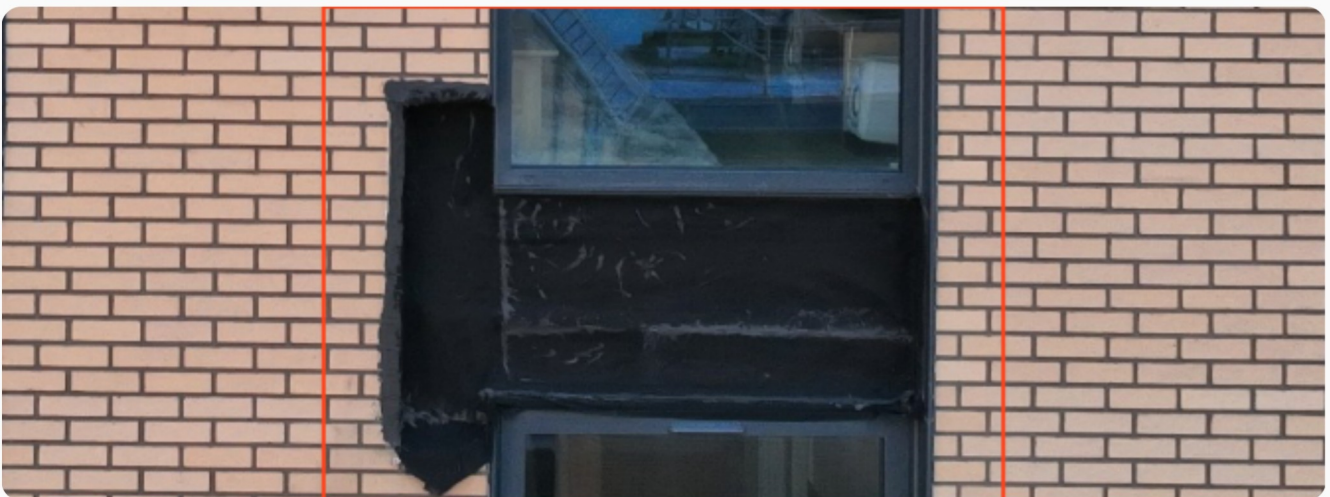
3

Severity 4

Damage

Cladding

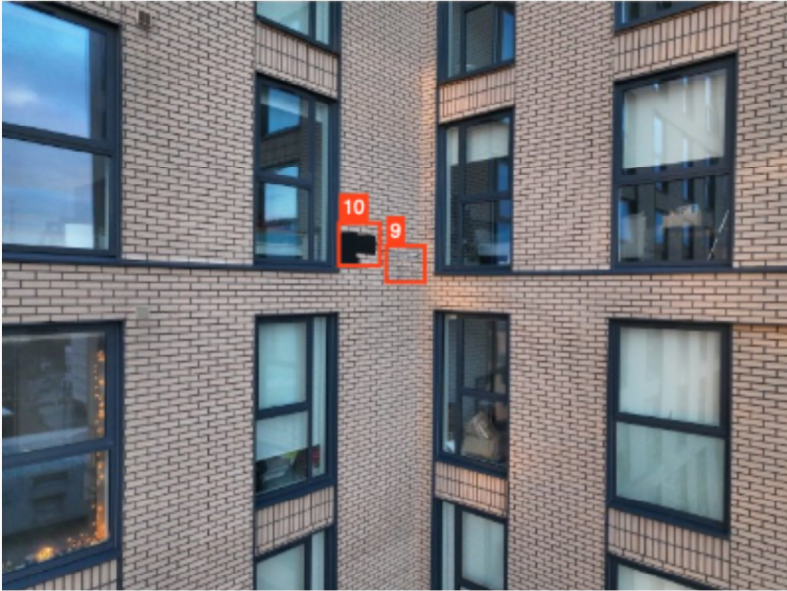
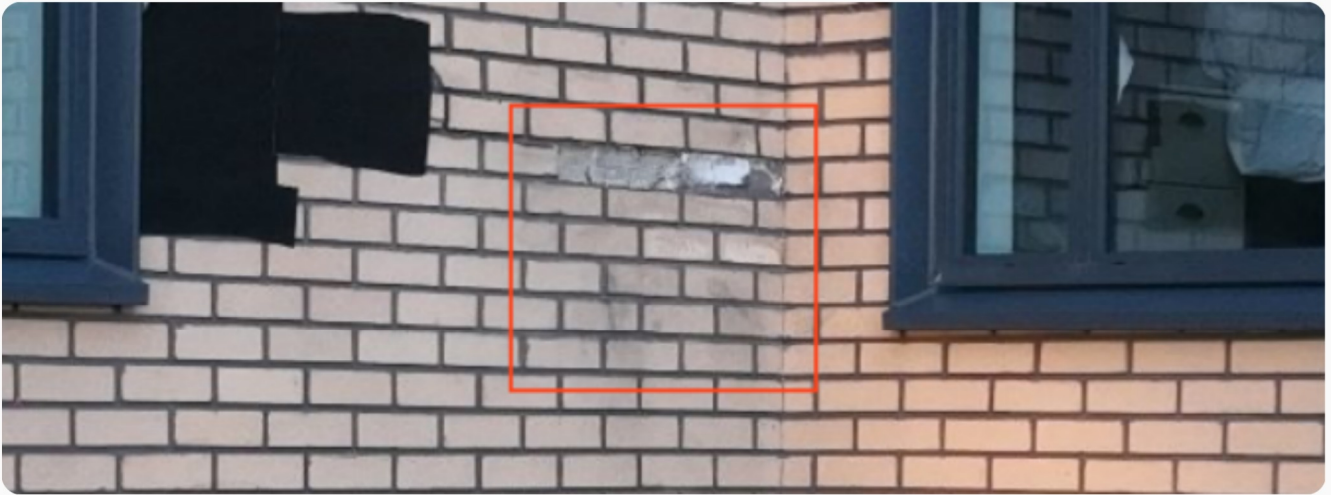
9

Severity 4

Damage

Cladding

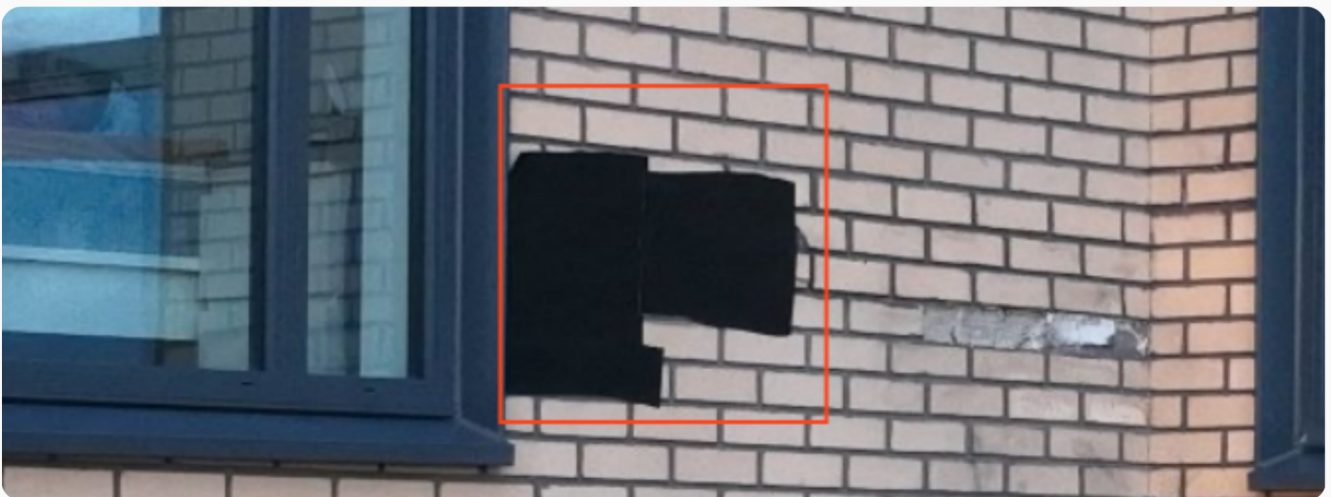
10

Severity 4

Damage

Cladding

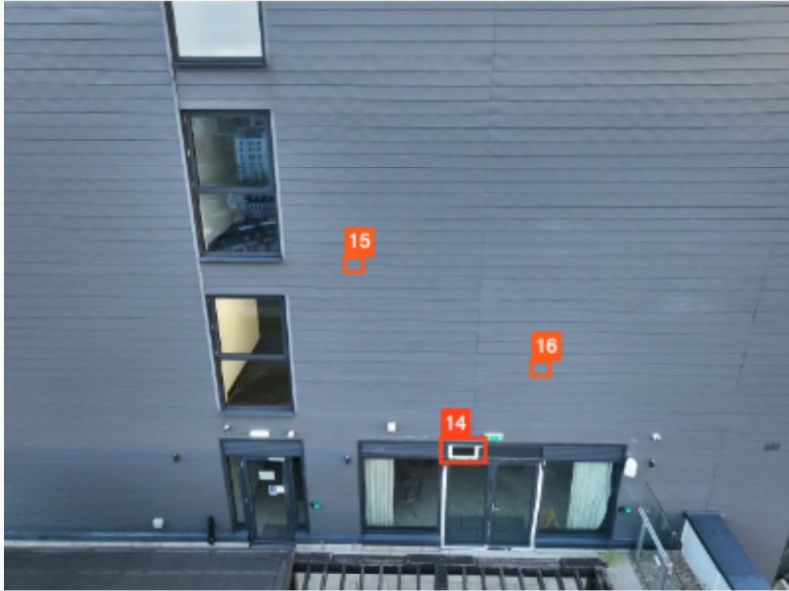
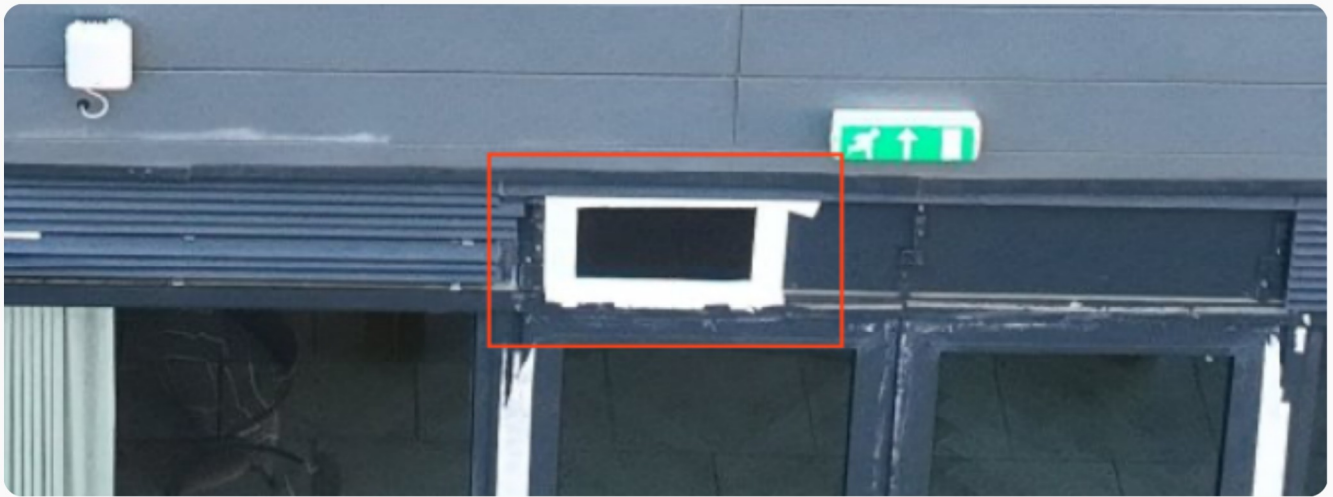
14

Severity 4

Damage

Cladding

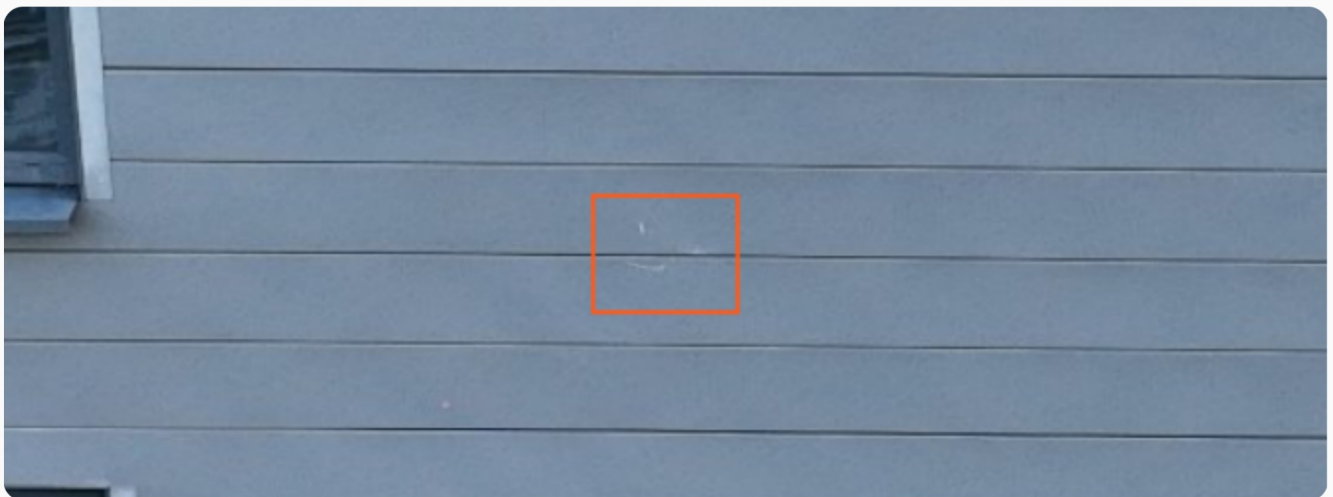
15

Severity 3

Damage

Cladding

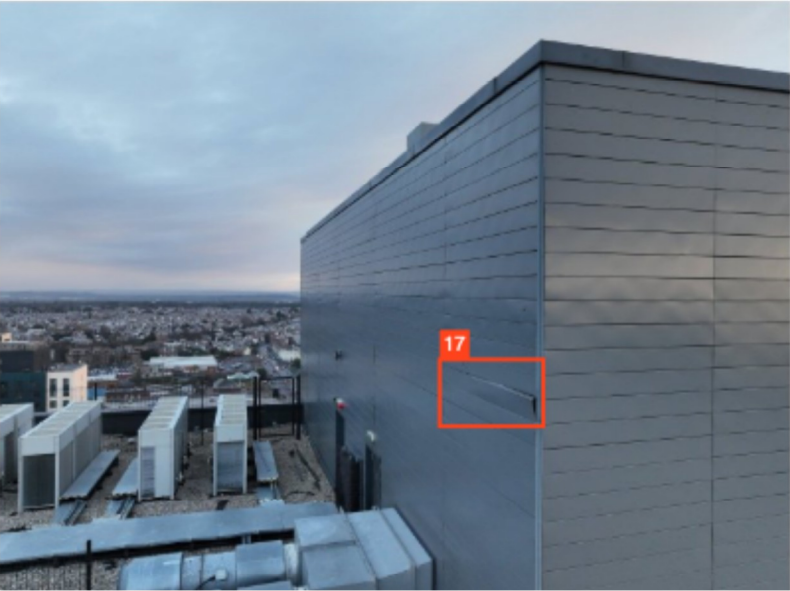
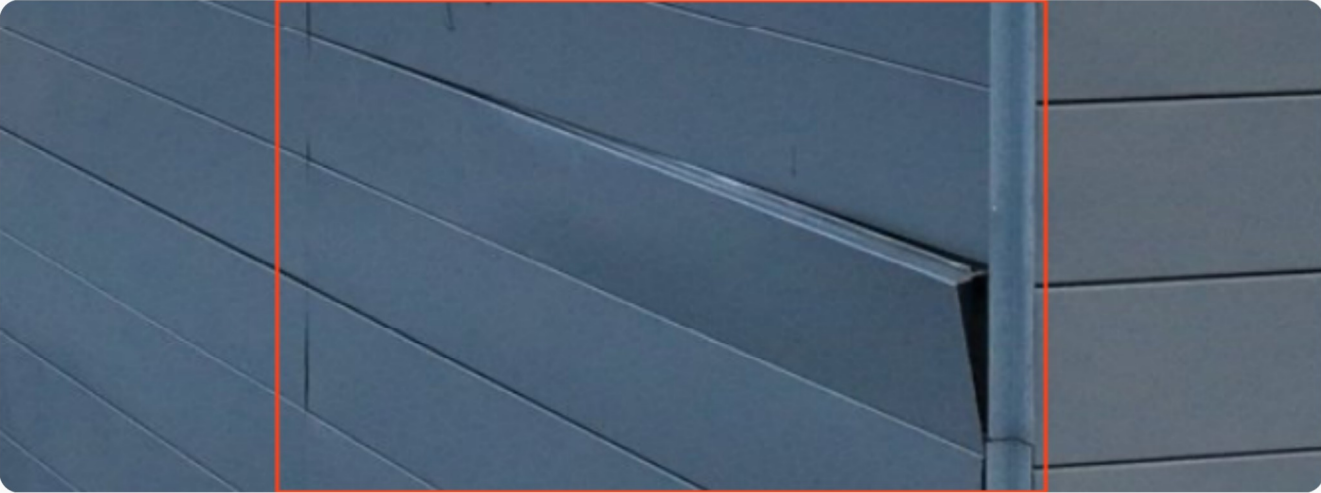
17

Severity 4

Damage

Cladding
