# Full View

Aerial Imaging Solutions

## Overview

## Analysis

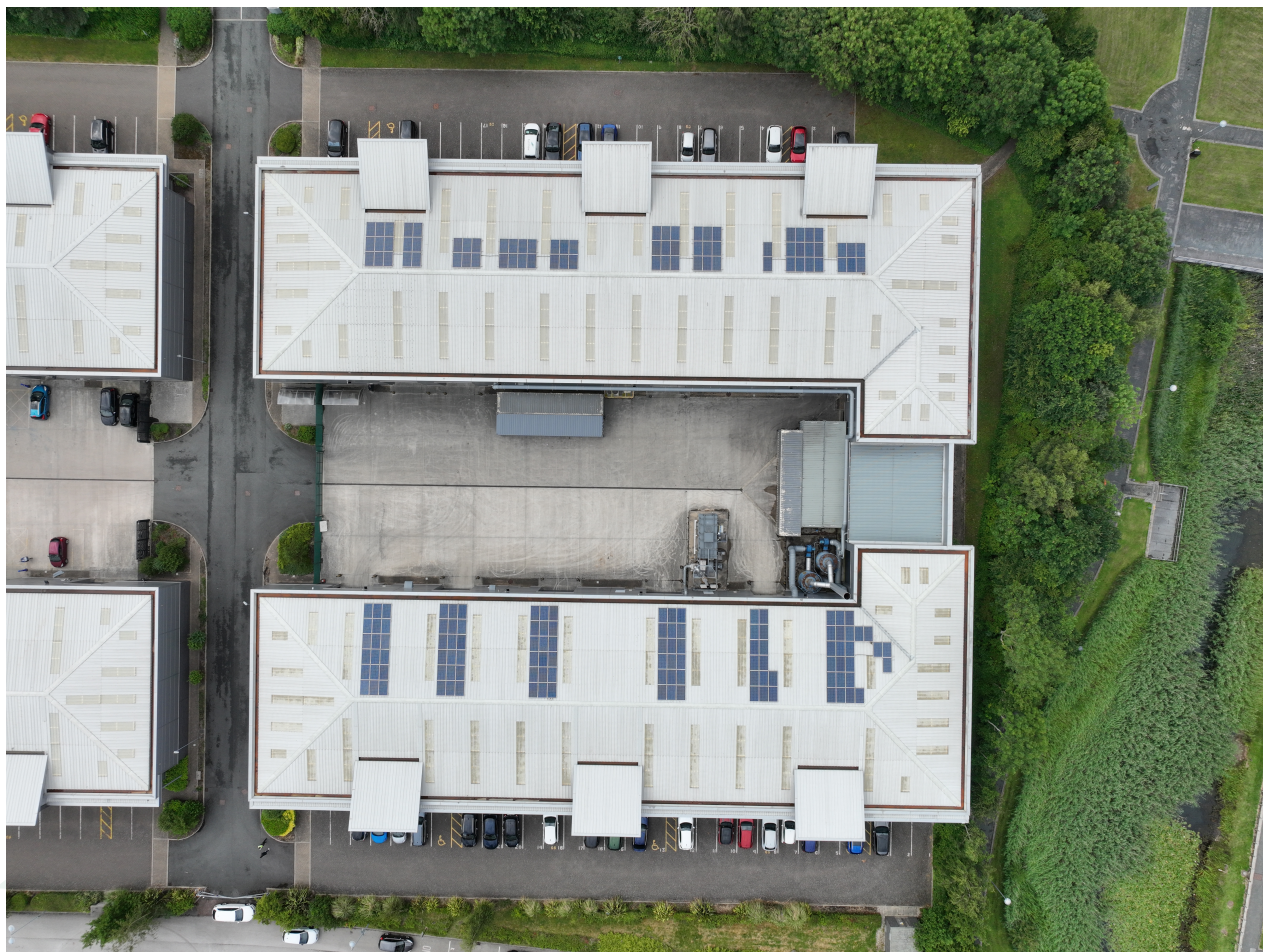
The areas in question consist of profiled metal roof sheets with a single pitch.

Rainwater goods consist of box gutters with gravity fed internal downpipes that discharge at ground level. There is a secondary gutter system around the perimeter of the building, with external downpipes that also discharge at ground level.

There is a solar PV system installed on a portion of the roof system, consisting of approximately 183 panels within the array.

There are multiple GRP roof lights across all elevations.

At the time of the survey no fall protection system was visible on any of the roofs
